# Access Compliance Report

## Public Rights-of-Way

### (Curb Ramps)

| Intersection ID: 2843 | Main Street: RIDGEFIELD_DR | Cross Street: WATERELM_LN | Location: NW |

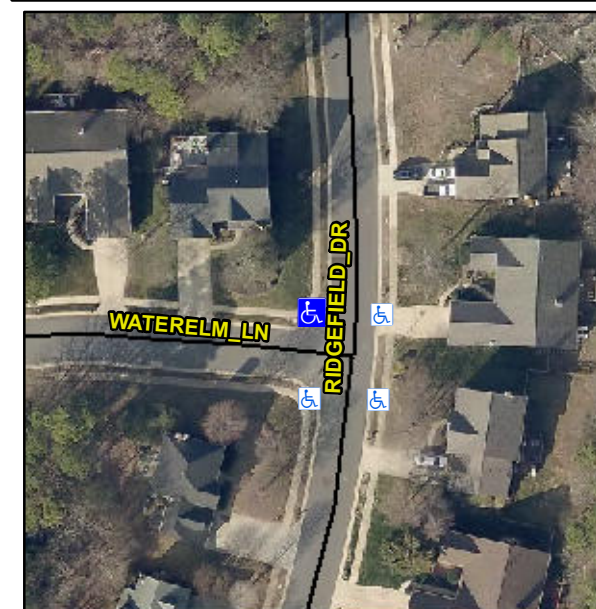
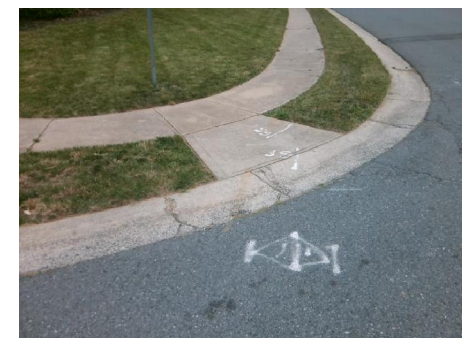
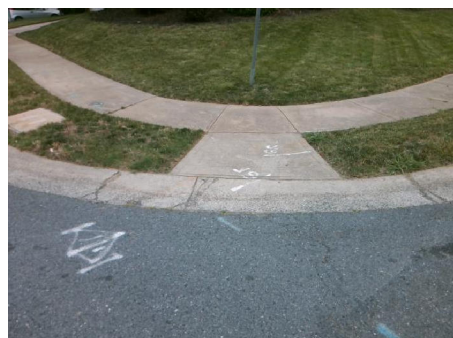
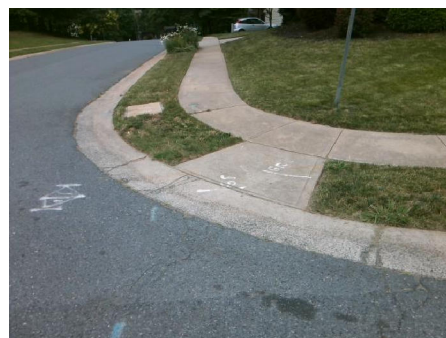
**Not Found, R304.5.3, R304.2.1, R304.2.2-Perp, R304.3.2-Para, R305, R304.5.4**

| Compliance | Description | Data | Compliance | Description | Data |
|---|---|---|---|---|---|
| Yes | Ramp Width (in) | 48.0 | No | BlendTrans XSlope (%) | 2.9 |
| Yes | Landing Length (in) | 48.0 | No | DWS Provided? | No |
| No | Landing Width (in) | 31.0 | N/A | DWS Contrast? | No |
| No | Landing Slope (%) | 2.9 | N/A | DWS Length (in) | N/A |
| No | Landing X Slope (%) | 2.8 | N/A | DWS Full Width? | No |
| Yes | Gutter Ponding? | No | No | Gutter Slope (%) | 8.1 |
| Yes | Gutter Lip Ht (in) | 0.0 | No | Gutter X Slope (%) | 2.2 |

**Remove & Replace Curb Ramp With Two New Directional Ramps or Equivalent. Remove & Replace Gutter.**
