Intersection ID: 11538	Main Street: FREEDOM_DR	Cross Street: BERRYHILL_RD	Location:	E
ADA ID: 184A1FDA13BE	Ramp Type: Perp	Initial Pass/Fail: Fail	Overall Compliance: No	Severity Score: 10

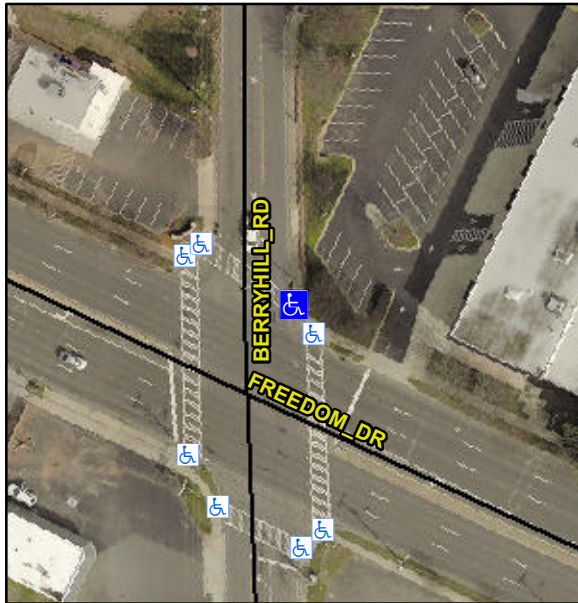
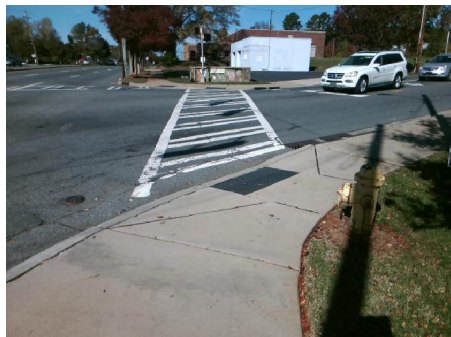
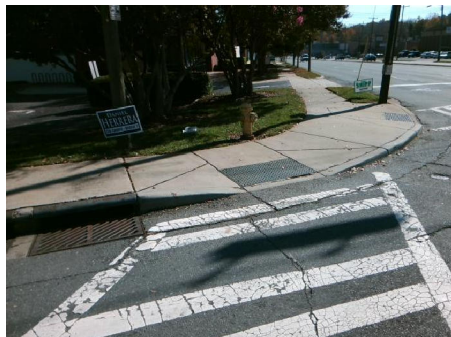
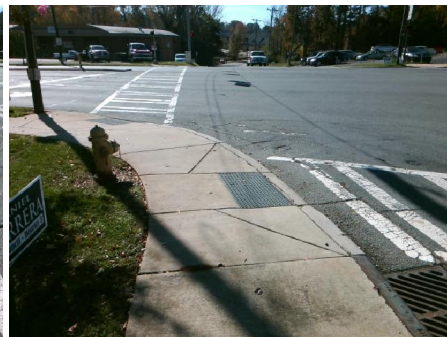
R304.5.1, R304.5.3

Compliance	Description	Data	Compliance	Description	Data
N/A	Ramp Length (in)	62.5	Yes	Ramp Slope (%)	5.1
No	Ramp Width (in)	47.5	No	Ramp XSlope (%)	3.9
N/A	Flare Type LT	N/A	N/A	Flare Type RT	N/A
N/A	Flare Slope LT (%)	N/A	N/A	Flare Slope RT (%)	N/A
N/A	Flare Traversable LT?	N/A	N/A	Flare Traversable RT?	N/A
N/A	Landing Length (in)	N/A	N/A	DWS Provided?	N/A
N/A	Landing Width (in)	N/A	N/A	DWS Contrast?	N/A
N/A	Landing Slope (%)	N/A	N/A	DWS Length (in)	N/A
N/A	Landing X Slope (%)	N/A	N/A	DWS Full Width?	N/A
N/A	Landing Curb? (Y/N)	N/A	N/A	DWS Offset (in)	N/A
N/A	Shared Landing?	N/A			
N/A	Gutter Ponding?	N/A	N/A	Gutter Slope (%)	N/A
N/A	Gutter Lip Ht (in)	N/A	N/A	Gutter X Slope (%)	N/A
N/A	Painted X Walk1?	Yes	N/A	Painted X Walk2?	N/A
	X Walk 1 Direction	To NW		X Walk 2 Direction	N/A
N/A	X Walk 1 Width (in)	105.0	N/A	X Walk 2 Width (in)	N/A
	X Walk 1 Slope (%)	3.5		X Walk 2 Slope (%)	N/A
	X Walk 1 X Slope (%)	2.5		X Walk 2 X Slope (%)	N/A

N/A	Ramp inside XWalk1?	Yes	N/A	Ramp inside XWalk2?	N/A
	Road Slope (%)	N/A	N/A	Clear Space?	N/A
	Road X Slope (%)	N/A	N/A	Clear Space to XWalk (in)	N/A
N/A	Any Obstructions?	N/A	N/A	Storm Grate/Utility Hazard?	N/A
	Obstruction Type			Storm Grate/Utility Type	
		N/A			N/A
			Yes	Surface Condition? (G/P)	Good

Remove & Replace Entire Ramp.
