Access Compliance Report Public Rights-of-Way (Curb Ramps)

Intersection ID: 52535 Main Street: TAMARRON DR Cross Street: CLAVEMORR_CASTLE_CT Location: SW ADA ID: 184CC5863AC7 Ramp Type: PerpDiag Initial Pass/Fail: Fail **Overall Compliance: No Severity Score:** 10

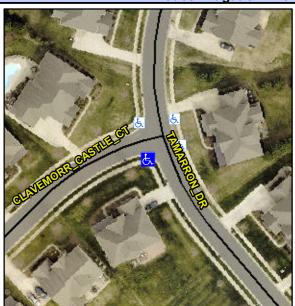
Field Measurements/Component Compliance							
	Compliance Description		Data	Compliance Description		Description	Data
	N/A	Ramp Length (in)	48.0	Yes	Ramp	Slope (%)	5.0
	No	Ramp Width (in)	47.0	No	Ramp	xSlope (%)	3.2
	N/A	Flare Type LT	N/A	N/A	Flare	Type RT	N/A
	N/A	Flare Slope LT (%)	N/A	N/A	Flare	Slope RT (%)	N/A
	N/A	Flare Traversable LT?	N/A	N/A	Flare	Traversable RT?	N/A
	N/A	Landing Length (in)	N/A	N/A	DWS	Provided?	N/A
	N/A	Landing Width (in)	N/A	N/A	DWS	Contrast?	N/A
	N/A	Landing Slope (%)	N/A	N/A	DWS	Length (in)	N/A
	N/A	Landing X Slope (%)	N/A	N/A	DWS	Full Width?	N/A
	N/A	Landing Curb? (Y/N)	N/A	N/A	DWS	Offset (in)	N/A
	N/A	Shared Landing?	N/A				
	N/A	Gutter Ponding?	N/A	N/A	Gutte	er Slope (%)	N/A
	N/A	Gutter Lip Ht (in)	N/A	N/A	Gutte	er X Slope (%)	N/A
	N/A	Painted X Walk1?	No	N/A	Paint	ed X Walk2?	No
		X Walk 1 Direction	To E		X Wa	lk 2 Direction	To N
	N/A	X Walk 1 Width (in)	N/A	N/A	X Wa	ılk 2 Width (in)	N/A

X Walk 1 Slope (%)	4.0		X Wa	ılk 2 Slope (%)	3.8
		X Walk 1 X Slope (%)	3.1		X Wa	ılk 2 X Slope (%)	0.4
	N/A	Ramp inside XWalk1?	N/A	N/A	Ram	p inside XWalk2?	N/A
		Road Slope (%)	0.3	N/A	Clear	Space?	N/A
		Road X Slope (%)	2.3	N/A	Clear	Space to XWalk (in)	N/A
	N/A	Any Obstructions?	N/A	N/A	Storn	n Grate/Utility Hazard?	N/A
		Obstruction Type			Storn	n Grate/Utility Type	
			N/A				N/A
				Yes	Surfa	ice Condition? (G/P)	Good
	是 A

Possible Solutions: Remove & Replace Curb Ramp With **Two New Directional Ramps or** Equivalent. Surveyor Notes: N/A PROW/ADA: Not Found, R304.5.1, R304.5.3
