Access Compliance Report

Public Rights-of-Way

(Curb Ramps)

Intersection ID: 10745	Main Street: E_35TH_ST	Cross Street: HOLT_ST	Location: SW
ADA ID: 186B508BD167	Ramp Type: Perp	Initial Pass/Fail: Fail	Overall Compliance: No
Codes/Mitigation Info/Possible Solution		Field Measurements/Component Compliance

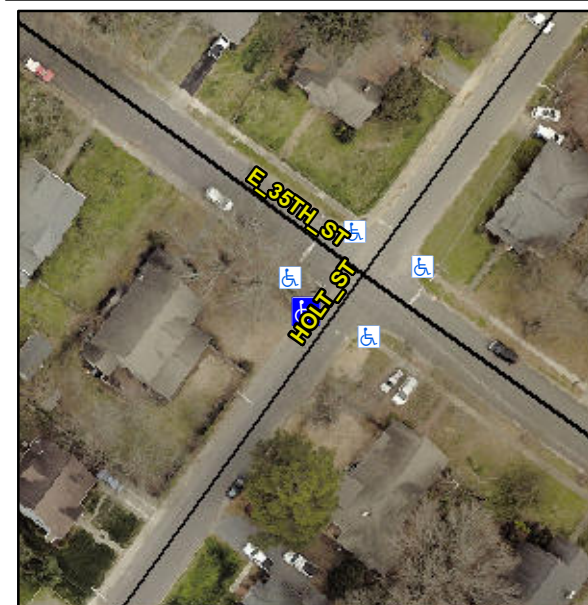
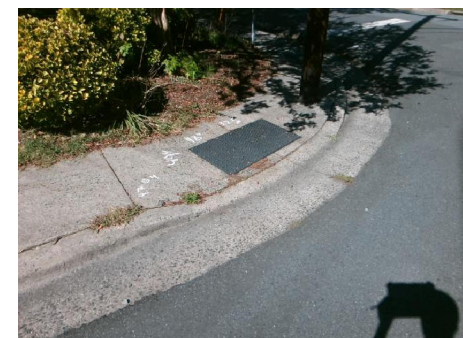
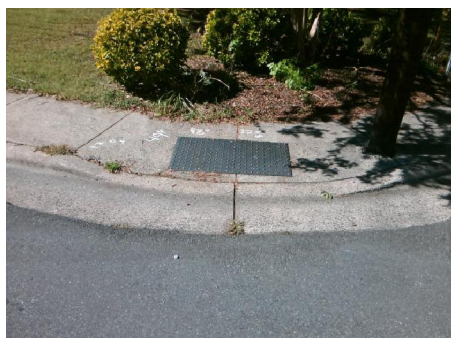
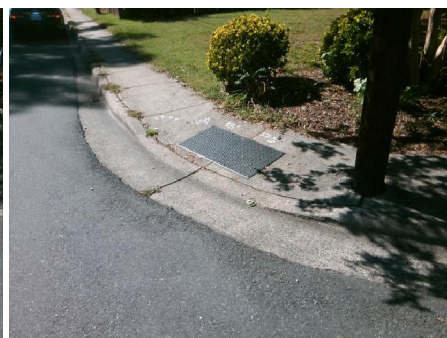
Not Found, R304.2.2, R304.5.3

Compliance	Description	Data	Compliance	Description	Data
N/A	Ramp Length (in)	49.0	No	Ramp Slope (%)	11.9
Yes	Ramp Width (in)	48.0	No	Ramp XSlope (%)	3.0
N/A	Flare Type LT	N/A	N/A	Flare Type RT	N/A
N/A	Flare Slope LT (%)	N/A	N/A	Flare Slope RT (%)	N/A
N/A	Flare Traversable LT?	N/A	N/A	Flare Traversable RT?	N/A
N/A	Landing Length (in)	N/A	N/A	DWS Provided?	N/A
N/A	Landing Width (in)	N/A	N/A	DWS Contrast?	N/A
N/A	Landing Slope (%)	N/A	N/A	DWS Length (in)	N/A
N/A	Landing X Slope (%)	N/A	N/A	DWS Full Width?	N/A
N/A	Landing Curb? (Y/N)	N/A	N/A	DWS Offset (in)	N/A
N/A	Shared Landing?	N/A			
N/A	Gutter Ponding?	N/A	N/A	Gutter Slope (%)	N/A
N/A	Gutter Lip Ht (in)	N/A	N/A	Gutter X Slope (%)	N/A
N/A	Painted X Walk1?	No	N/A	Painted X Walk2?	N/A
	X Walk 1 Direction	To SE		X Walk 2 Direction	N/A
N/A	X Walk 1 Width (in)	N/A	N/A	X Walk 2 Width (in)	N/A
	X Walk 1 Slope (%)	4.7		X Walk 2 Slope (%)	N/A
	X Walk 1 X Slope (%)	0.4		X Walk 2 X Slope (%)	N/A

N/A	Ramp inside XWalk1?	N/A	N/A	Ramp inside XWalk2?	N/A
	Road Slope (%)	N/A	N/A	Clear Space?	N/A
	Road X Slope (%)	N/A	N/A	Clear Space to XWalk (in)	N/A
N/A	Any Obstructions?	N/A	N/A	Storm Grate/Utility Hazard?	N/A
	Obstruction Type			Storm Grate/Utility Type	
		N/A			N/A
			Yes	Surface Condition? (G/P)	Good

Possible Solutions:

Remove & Replace Entire Ramp.

Total Cost: \$ 1850.00
