# Access Compliance Report

## Public Rights-of-Way

### (Curb Ramps)

| Intersection ID: 48955 | Main Street: ROYA_PL | Cross Street: DAVID_JENNINGS_AV | Location: S |

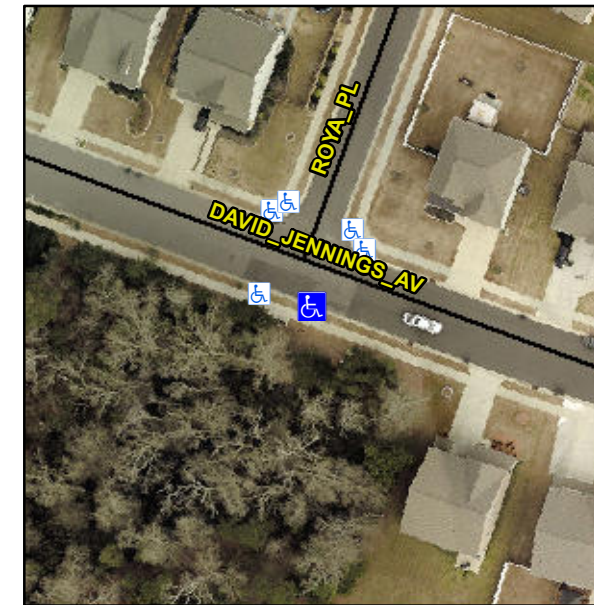
**Not Found, R304.5.1**

| Compliance | Description | Data | Compliance | Description | Data |
|---|---|---|---|---|---|
| No | Ramp Width (in) | 47.0 | Yes | Ramp XSlope (%) | 1.8 |

**Remove & Replace Entire Ramp.**
