Intersection ID: 3445	Main Street: BELDEGREEN_CT	Cross Street: LONDONSHIRE_DR	Location:	N/A
ADA ID: 18744EB165AC	Ramp Type: Perp	Initial Pass/Fail: Fail	Overall Compliance: No	Severity Score: 10

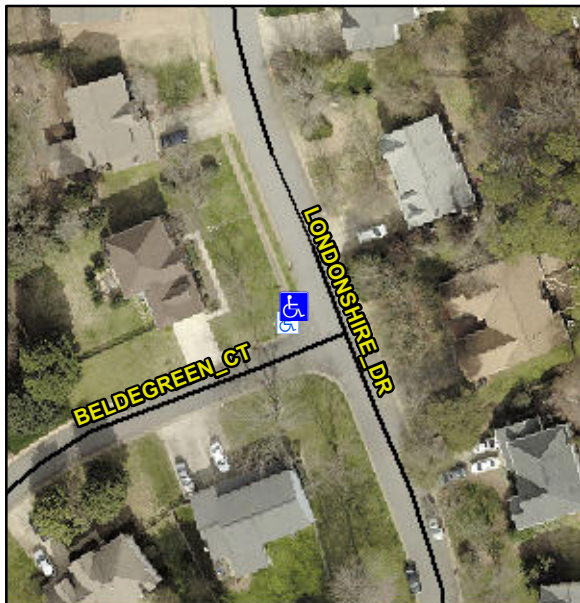
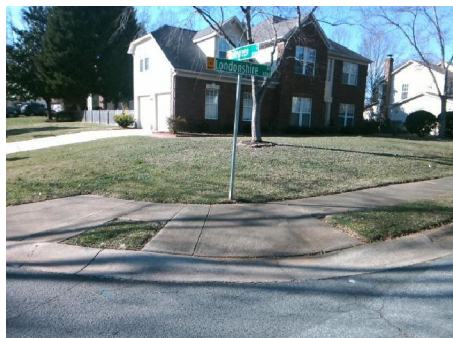
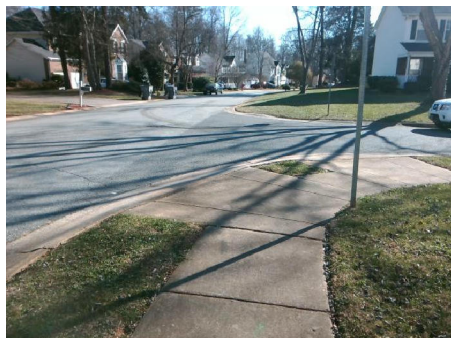
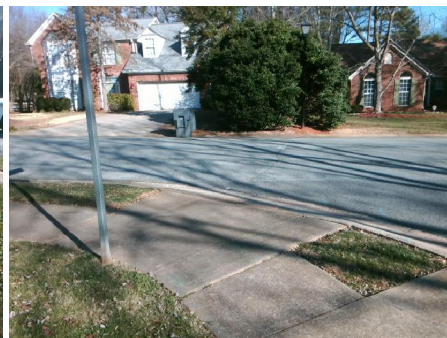
Possible Solutions:		Remove & Replace Entire Ramp.					
	Surveyor Notes:		N/A					
	PROW/ADA:		R304.5.1					
	Street 1 Name		LONDONSHIRE DR					
	Stop Condition-Street 2		None					
	Street 2 Name		N/A					
	Stop Condition-Street 1		N/A					
	Total Cost:		\$ 1850.00					
			Compliance	Description	Data	Compliance	Description	Data
			N/A	Ramp Length (in)	92.0	Yes	Ramp Slope (%)	6.0
			No	Ramp Width (in)	43.0	Yes	Ramp XSlope (%)	2.5
			N/A	Flare Type LT	N/A	N/A	Flare Type RT	N/A
			N/A	Flare Slope LT (%)	N/A	N/A	Flare Slope RT (%)	N/A
			N/A	Flare Traversable LT?	N/A	N/A	Flare Traversable RT?	N/A
			N/A	Landing Length (in)	N/A	N/A	DWS Provided?	N/A
			N/A	Landing Width (in)	N/A	N/A	DWS Contrast?	N/A
			N/A	Landing Slope (%)	N/A	N/A	DWS Length (in)	N/A
			N/A	Landing X Slope (%)	N/A	N/A	DWS Full Width?	N/A
			N/A	Landing Curb? (Y/N)	N/A	N/A	DWS Offset (in)	N/A

N/A	Shared Landing?	N/A			
			N/A	Gutter Ponding?	N/A	N/A	Gutter Slope (%)	N/A
			N/A	Gutter Lip Ht (in)	N/A	N/A	Gutter X Slope (%)	N/A
			N/A	Painted X Walk1?	No	N/A	Painted X Walk2?	N/A
				X Walk 1 Direction	To E		X Walk 2 Direction	N/A
			N/A	X Walk 1 Width (in)	N/A	N/A	X Walk 2 Width (in)	N/A
				X Walk 1 Slope (%)	3.7		X Walk 2 Slope (%)	N/A
				X Walk 1 X Slope (%)	5.6		X Walk 2 X Slope (%)	N/A
			N/A	Ramp inside XWalk1?	N/A	N/A	Ramp inside XWalk2?	N/A
				Road Slope (%)	5.6	N/A	Clear Space?	N/A
				Road X Slope (%)	3.7	N/A	Clear Space to XWalk (in)	N/A
			N/A	Any Obstructions?	N/A	N/A	Storm Grate/Utility Hazard?	N/A
				Obstruction Type			Storm Grate/Utility Type	
					N/A			N/A
						Yes	Surface Condition? (G/P)	Good
