Access Compliance Report

Public Rights-of-Way

(Curb Ramps)

Intersection ID: 20786	Main Street: SHARON_VIEW_RD	Cross Street: SHARON_WOODS_LN	Location: SE
ADA ID: 1880ADE1A8C8	Ramp Type: PerpDiag	Initial Pass/Fail: Fail	Overall Compliance: No
Severity Score: 22.5			
Codes/Mitigation Info/Possible Solution		Field Measurements/Component Compliance

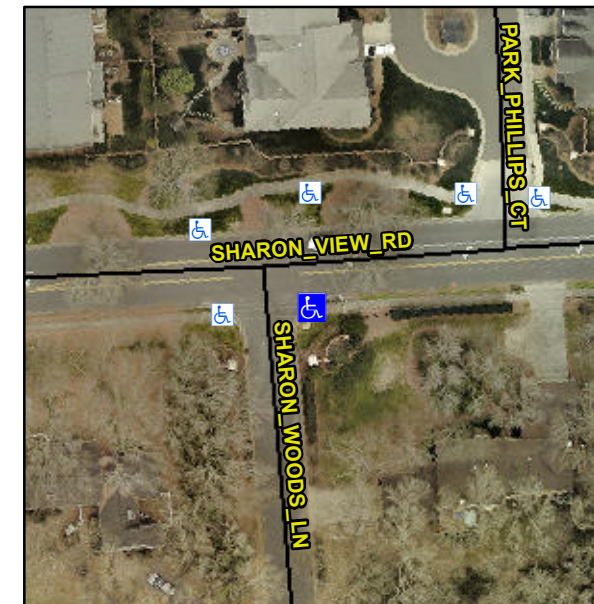
Not Found, R304.5.1, R304.2.2, R304.5.3

Compliance	Description	Data	Compliance	Description	Data
N/A	Ramp Length (in)	48.0	No	Ramp Slope (%)	10.4
No	Ramp Width (in)	44.0	No	Ramp XSlope (%)	2.1
N/A	Flare Type LT	N/A	N/A	Flare Type RT	N/A
N/A	Flare Slope LT (%)	N/A	N/A	Flare Slope RT (%)	N/A
N/A	Flare Traversable LT?	N/A	N/A	Flare Traversable RT?	N/A
N/A	Landing Length (in)	N/A	N/A	DWS Provided?	N/A
N/A	Landing Width (in)	N/A	N/A	DWS Contrast?	N/A
N/A	Landing Slope (%)	N/A	N/A	DWS Length (in)	N/A
N/A	Landing X Slope (%)	N/A	N/A	DWS Full Width?	N/A
N/A	Landing Curb? (Y/N)	N/A	N/A	DWS Offset (in)	N/A
N/A	Shared Landing?	N/A			
N/A	Gutter Ponding?	N/A	N/A	Gutter Slope (%)	N/A
N/A	Gutter Lip Ht (in)	N/A	N/A	Gutter X Slope (%)	N/A
N/A	Painted X Walk1?	No	N/A	Painted X Walk2?	No
	X Walk 1 Direction	To NE		X Walk 2 Direction	To NW
N/A	X Walk 1 Width (in)	N/A	N/A	X Walk 2 Width (in)	N/A
	X Walk 1 Slope (%)	9.3		X Walk 2 Slope (%)	3.3
	X Walk 1 X Slope (%)	3.6		X Walk 2 X Slope (%)	8.2

N/A	Ramp inside XWalk1?	N/A	N/A	Ramp inside XWalk2?	N/A
	Road Slope (%)	2.5	N/A	Clear Space?	N/A
	Road X Slope (%)	14.4	N/A	Clear Space to XWalk (in)	N/A
N/A	Any Obstructions?	N/A	N/A	Storm Grate/Utility Hazard?	N/A
	Obstruction Type			Storm Grate/Utility Type	
		N/A			N/A
			Yes	Surface Condition? (G/P)	Good

Remove & Replace Curb Ramp With Two New Directional Ramps or Equivalent.
