# Access Compliance Report

## Public Rights-of-Way

### (Curb Ramps)

Intersection ID: 3114	Main Street: BROWNESTONE_VIEW_DR	Cross Street: RIDGELINE_LN	Location:	S
ADA ID: 1887385FD7DB	Ramp Type: PerpDiag	Initial Pass/Fail: Fail	Overall Compliance: No	Severity Score: 10
Codes/Mitigation Info/Possible Solution		Field Measurements/Component Compliance

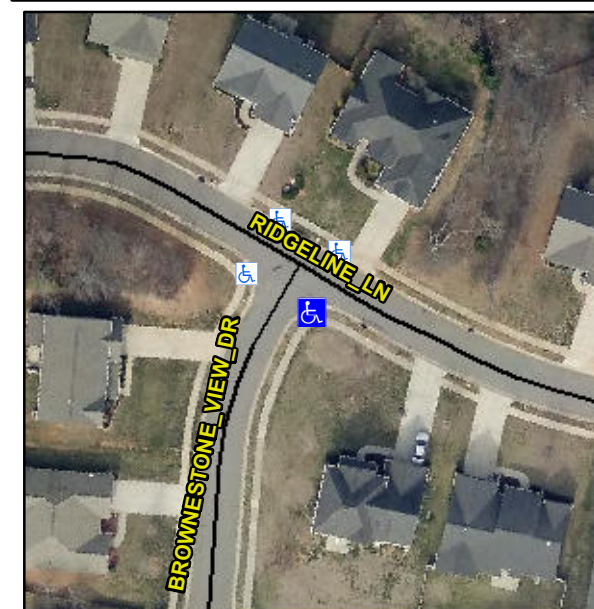
**Not Found, R304.5.1, R304.5.3**

Compliance	Description	Data	Compliance	Description	Data
N/A	Ramp Length (in)	47.5	Yes	Ramp Slope (%)	5.5
No	Ramp Width (in)	45.0	No	Ramp XSlope (%)	4.0
N/A	Flare Type LT	N/A	N/A	Flare Type RT	N/A
N/A	Flare Slope LT (%)	N/A	N/A	Flare Slope RT (%)	N/A
N/A	Flare Traversable LT?	N/A	N/A	Flare Traversable RT?	N/A
N/A	Landing Length (in)	N/A	N/A	DWS Provided?	N/A
N/A	Landing Width (in)	N/A	N/A	DWS Contrast?	N/A
N/A	Landing Slope (%)	N/A	N/A	DWS Length (in)	N/A
N/A	Landing X Slope (%)	N/A	N/A	DWS Full Width?	N/A
N/A	Landing Curb? (Y/N)	N/A	N/A	DWS Offset (in)	N/A
N/A	Shared Landing?	N/A			
N/A	Gutter Ponding?	N/A	N/A	Gutter Slope (%)	N/A
N/A	Gutter Lip Ht (in)	N/A	N/A	Gutter X Slope (%)	N/A
N/A	Painted X Walk1?	No	N/A	Painted X Walk2?	No
	X Walk 1 Direction	To NE		X Walk 2 Direction	To NW
N/A	X Walk 1 Width (in)	N/A	N/A	X Walk 2 Width (in)	N/A
	X Walk 1 Slope (%)	5.0		X Walk 2 Slope (%)	0.1
	X Walk 1 X Slope (%)	0.6		X Walk 2 X Slope (%)	5.6

N/A	Ramp inside XWalk1?	N/A	N/A	Ramp inside XWalk2?	N/A
	Road Slope (%)	4.1	N/A	Clear Space?	N/A
	Road X Slope (%)	4.6	N/A	Clear Space to XWalk (in)	N/A
N/A	Any Obstructions?	N/A	N/A	Storm Grate/Utility Hazard?	N/A
	Obstruction Type			Storm Grate/Utility Type	
		N/A			N/A
			Yes	Surface Condition? (G/P)	Good

**Remove & Replace Curb Ramp With Two New Directional Ramps or Equivalent.**
