Access Compliance Report

Public Rights-of-Way

(Curb Ramps)

Intersection ID: 22467		Main Street: CARMEL_RD		Cross Street: TOTTENHAM_RD		Location:		N									
ADA ID: 1895D2F468B1		Ramp Type: Directional1		Initial Pass/Fail: Fail		Overall Compliance: No		Severity Score: 12.5									
Codes/Mitigation Info/Possible Solution				Field Measurements/Component Compliance													
<div>

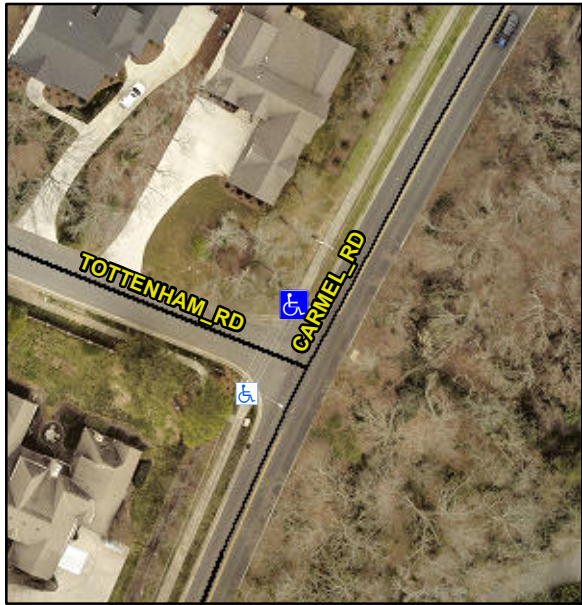
</div> <div>Possible Solutions:</div> <div>Remove & Replace Entire Ramp.</div> <div>Surveyor Notes:</div> <div>N/A</div> <div>PROW/ADA:</div> <div>R304.2.2</div> <div>Street 1 Name</div> <div>TOTTENHAM RD</div> <div>Stop Condition-Street 1</div> <div>StopSign</div> <div>Street 2 Name</div> <div>N/A</div> <div>Stop Condition-Street 2</div> <div>N/A</div> <div>Total Cost:</div> <div>\$</div> <div>1600.00</div>				Compliance		Description		Data		Compliance		Description		Data			
				N/A		Ramp Length (in)		83.0		N/A		Grade Break?		N/A		N/A	
				Yes		Ramp Width (in)		59.0		N/A		Grade Break Slope (%)		0.0		0.0

No		Ramp Slope (%)		11.8		N/A		Grade Break XSlope (%)		0.0		0.0	
				Yes		Ramp XSlope (%)		1.0									
				N/A		Flare Type LT		N/A		N/A		Flare Type RT		N/A		N/A	
				N/A		Flare Slope LT (%)		N/A		N/A		Flare Slope RT (%)		0.0		0.0	
				N/A		Flare Traversable LT?		N/A		N/A		Flare Traversable RT?		N/A		N/A	
				N/A		Landing Length (in)		0.0		N/A		DWS Provided?		N/A		N/A	
				N/A		Landing Width (in)		0.0		N/A		DWS Contrast?		N/A		N/A	
				N/A		Landing Slope (%)		0.0		N/A		DWS Length (in)		N/A		N/A	
				N/A		Landing X Slope (%)		0.0		N/A		DWS Full Width?		N/A		N/A	
				N/A		Landing Curb? (Y/N)		N/A		N/A		DWS Offset LT (in)		N/A		N/A	
				N/A		Shared Landing?		N/A		N/A		DWS Offset RT (in)		N/A		N/A	
				N/A		Gutter Ponding?		0.0		N/A		Gutter Slope (%)		N/A		N/A	
				N/A		Gutter Lip Ht (in)		0.0		N/A		Gutter X Slope (%)		N/A		N/A	
				N/A		Painted X Walk1?		No				Road Slope (%)		1.8		1.8	
						X Walk 1 Direction		To S				Road X Slope (%)		3.8		3.8

X Walk 1 Width (in)		N/A				Clear Space?		N/A		N/A	
						X Walk 1 Slope (%)		1.8		N/A		Clear Space to XWalk (in)		N/A		N/A	
						X Walk 1 X Slope (%)		3.8		N/A		Storm Grate/Utility Hazard?		N/A		N/A	
				N/A		Ramp inside XWalk1?		N/A				Storm Grate/Utility Type					
				N/A		Any Obstructions?		N/A						N/A		N/A	
						Obstruction Type				Yes		Surface Condition? (G/P)		Good		Good	
										N/A		N/A		Curb Slope (%)		2.5
