# Access Compliance Report

## Public Rights-of-Way

### (Curb Ramps)

Intersection ID: 13098	Main Street: S_CHURCH_ST	Cross Street: LINCOLN_ST	Location: SE
ADA ID: 18B00135EB83	Ramp Type: PerpDiag	Initial Pass/Fail: Fail	Overall Compliance: No
Severity Score: 13.75			
Codes/Mitigation Info/Possible Solution		Field Measurements/Component Compliance

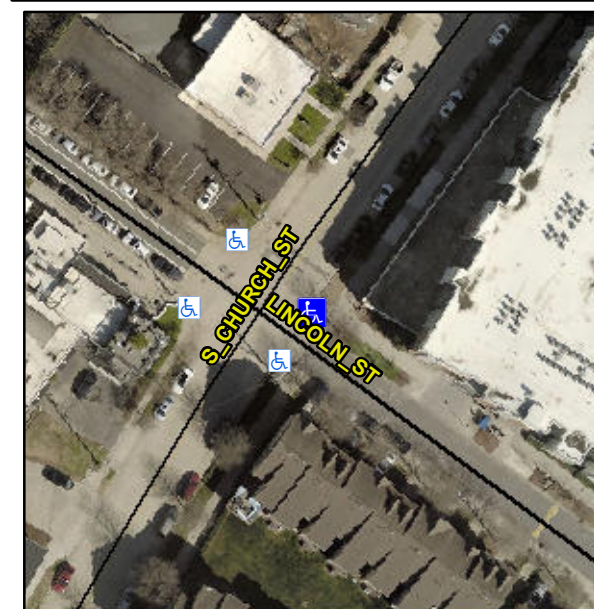
**Not Found, R304.2.2, R304.5.3**

Compliance	Description	Data	Compliance	Description	Data
N/A	Ramp Length (in)	64.0	No	Ramp Slope (%)	9.4
Yes	Ramp Width (in)	48.0	No	Ramp XSlope (%)	4.9
N/A	Flare Type LT	N/A	N/A	Flare Type RT	N/A
N/A	Flare Slope LT (%)	N/A	N/A	Flare Slope RT (%)	N/A
N/A	Flare Traversable LT?	N/A	N/A	Flare Traversable RT?	N/A
N/A	Landing Length (in)	N/A	N/A	DWS Provided?	N/A
N/A	Landing Width (in)	N/A	N/A	DWS Contrast?	N/A
N/A	Landing Slope (%)	N/A	N/A	DWS Length (in)	N/A
N/A	Landing X Slope (%)	N/A	N/A	DWS Full Width?	N/A
N/A	Landing Curb? (Y/N)	N/A	N/A	DWS Offset (in)	N/A
N/A	Shared Landing?	N/A			
N/A	Gutter Ponding?	N/A	N/A	Gutter Slope (%)	N/A
N/A	Gutter Lip Ht (in)	N/A	N/A	Gutter X Slope (%)	N/A
N/A	Painted X Walk1?	No	N/A	Painted X Walk2?	No
	X Walk 1 Direction	To NW		X Walk 2 Direction	To SW
N/A	X Walk 1 Width (in)	N/A	N/A	X Walk 2 Width (in)	N/A
	X Walk 1 Slope (%)	2.9		X Walk 2 Slope (%)	0.7
	X Walk 1 X Slope (%)	0.7		X Walk 2 X Slope (%)	0.9

N/A	Ramp inside XWalk1?	N/A	N/A	Ramp inside XWalk2?	N/A
	Road Slope (%)	0.3	N/A	Clear Space?	N/A
	Road X Slope (%)	1.5	N/A	Clear Space to XWalk (in)	N/A
N/A	Any Obstructions?	N/A	N/A	Storm Grate/Utility Hazard?	N/A
	Obstruction Type			Storm Grate/Utility Type	
		N/A			N/A
		Yes		Surface Condition? (G/P)	Good

**Remove & Replace Curb Ramp With Two New Directional Ramps or Equivalent.**

Total Cost: \$ 3200.00
