Access Compliance Report

Public Rights-of-Way

(Curb Ramps)

Intersection ID: 6364	Main Street: SONOMA_VALLEY_DR	Cross Street: RHYNE_RD	Location: NW
ADA ID: 18C4237A8B5D	Ramp Type: Perp	Initial Pass/Fail: Fail	Overall Compliance: No
Codes/Mitigation Info/Possible Solution		Field Measurements/Component Compliance

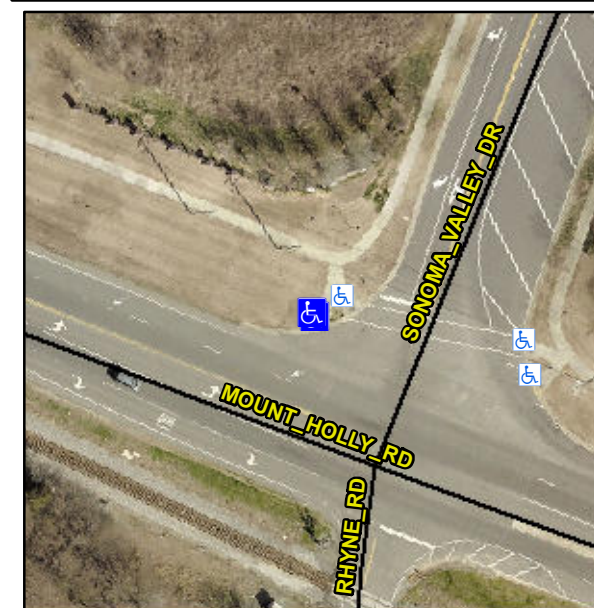
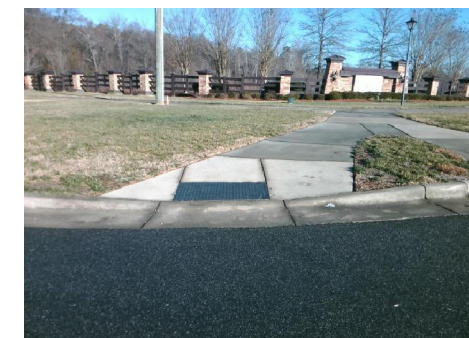
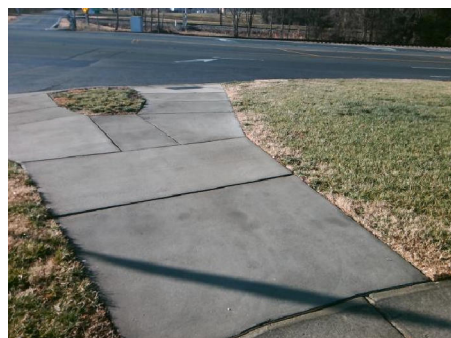
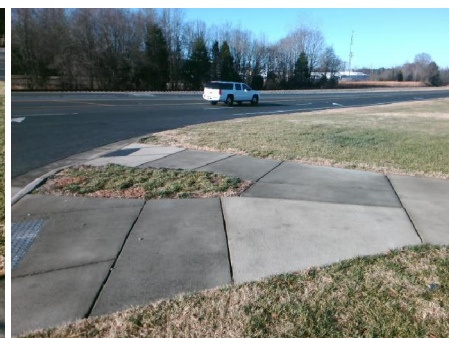
Not Found, R304.2.2, R304.5.3

Compliance	Description	Data	Compliance	Description	Data
N/A	Ramp Length (in)	54.0	No	Ramp Slope (%)	9.1
Yes	Ramp Width (in)	48.0	No	Ramp XSlope (%)	3.6
N/A	Flare Type LT	N/A	N/A	Flare Type RT	N/A
N/A	Flare Slope LT (%)	N/A	N/A	Flare Slope RT (%)	N/A
N/A	Flare Traversable LT?	N/A	N/A	Flare Traversable RT?	N/A
N/A	Landing Length (in)	N/A	N/A	DWS Provided?	N/A
N/A	Landing Width (in)	N/A	N/A	DWS Contrast?	N/A
N/A	Landing Slope (%)	N/A	N/A	DWS Length (in)	N/A
N/A	Landing X Slope (%)	N/A	N/A	DWS Full Width?	N/A
N/A	Landing Curb? (Y/N)	N/A	N/A	DWS Offset (in)	N/A
N/A	Shared Landing?	N/A			
N/A	Gutter Ponding?	N/A	N/A	Gutter Slope (%)	N/A
N/A	Gutter Lip Ht (in)	N/A	N/A	Gutter X Slope (%)	N/A
N/A	Painted X Walk1?	No	N/A	Painted X Walk2?	N/A
	X Walk 1 Direction	To S		X Walk 2 Direction	N/A
N/A	X Walk 1 Width (in)	N/A	N/A	X Walk 2 Width (in)	N/A
	X Walk 1 Slope (%)	0.3		X Walk 2 Slope (%)	N/A
	X Walk 1 X Slope (%)	3.2		X Walk 2 X Slope (%)	N/A

N/A	Ramp inside XWalk1?	N/A	N/A	Ramp inside XWalk2?	N/A
	Road Slope (%)	3.2	N/A	Clear Space?	N/A
	Road X Slope (%)	0.3	N/A	Clear Space to XWalk (in)	N/A
N/A	Any Obstructions?	N/A	N/A	Storm Grate/Utility Hazard?	N/A
	Obstruction Type			Storm Grate/Utility Type	
		N/A			N/A
			Yes	Surface Condition? (G/P)	Good

Remove & Replace Entire Ramp.
