Access Compliance Report

Public Rights-of-Way

(Curb Ramps)

Intersection ID: 15160	Main Street: GRIFFITH_ST	Cross Street: S_TRYON_ST	Location: NE
ADA ID: 18C4D5B438AF	Ramp Type: Perp	Initial Pass/Fail: Fail	Overall Compliance: No
Severity Score: 22.5			
Codes/Mitigation Info/Possible Solution		Field Measurements/Component Compliance

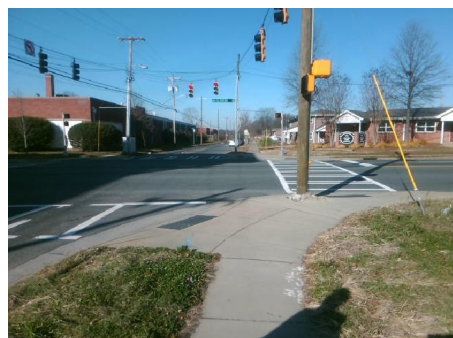
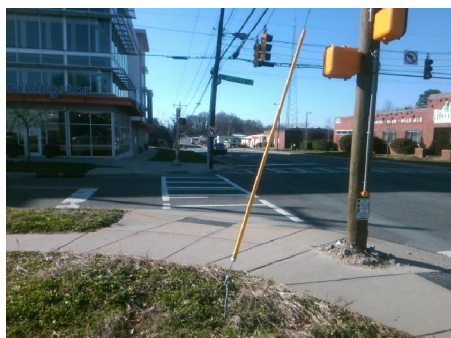
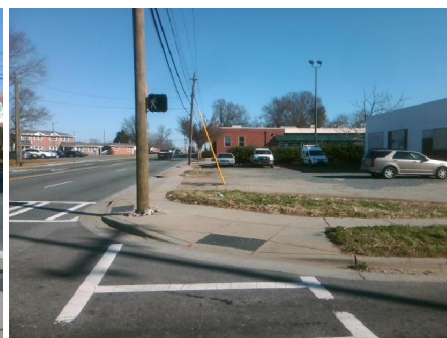
Not Found, R304.5.1, R304.2.2, R304.5.3

Compliance	Description	Data	Compliance	Description	Data
N/A	Ramp Length (in)	67.0	No	Ramp Slope (%)	9.5
No	Ramp Width (in)	47.5	No	Ramp XSlope (%)	2.1
N/A	Flare Type LT	N/A	N/A	Flare Type RT	N/A
N/A	Flare Slope LT (%)	N/A	N/A	Flare Slope RT (%)	N/A
N/A	Flare Traversable LT?	N/A	N/A	Flare Traversable RT?	N/A
N/A	Landing Length (in)	N/A	N/A	DWS Provided?	N/A
N/A	Landing Width (in)	N/A	N/A	DWS Contrast?	N/A
N/A	Landing Slope (%)	N/A	N/A	DWS Length (in)	N/A
N/A	Landing X Slope (%)	N/A	N/A	DWS Full Width?	N/A
N/A	Landing Curb? (Y/N)	N/A	N/A	DWS Offset (in)	N/A
N/A	Shared Landing?	N/A			
N/A	Gutter Ponding?	N/A	N/A	Gutter Slope (%)	N/A
N/A	Gutter Lip Ht (in)	N/A	N/A	Gutter X Slope (%)	N/A
N/A	Painted X Walk1?	Yes	N/A	Painted X Walk2?	N/A
	X Walk 1 Direction	To SW		X Walk 2 Direction	N/A
N/A	X Walk 1 Width (in)	105.0	N/A	X Walk 2 Width (in)	N/A
	X Walk 1 Slope (%)	1.0		X Walk 2 Slope (%)	N/A
	X Walk 1 X Slope (%)	0.8		X Walk 2 X Slope (%)	N/A

N/A	Ramp inside XWalk1?	Yes	N/A	Ramp inside XWalk2?	N/A
	Road Slope (%)	N/A	N/A	Clear Space?	N/A
	Road X Slope (%)	N/A	N/A	Clear Space to XWalk (in)	N/A
N/A	Any Obstructions?	N/A	N/A	Storm Grate/Utility Hazard?	N/A
	Obstruction Type			Storm Grate/Utility Type	
		N/A			N/A
			Yes	Surface Condition? (G/P)	Good

Remove & Replace Entire Ramp.
