Access Compliance Report

Public Rights-of-Way

(Curb Ramps)

Intersection ID: 14391	Main Street: E_PARK_AV	Cross Street: SPRINGDALE_AV	Location: NE
ADA ID: 18C6C7E6F561	Ramp Type: Combination2	Initial Pass/Fail: Fail	Overall Compliance: No
		Severity Score: 55

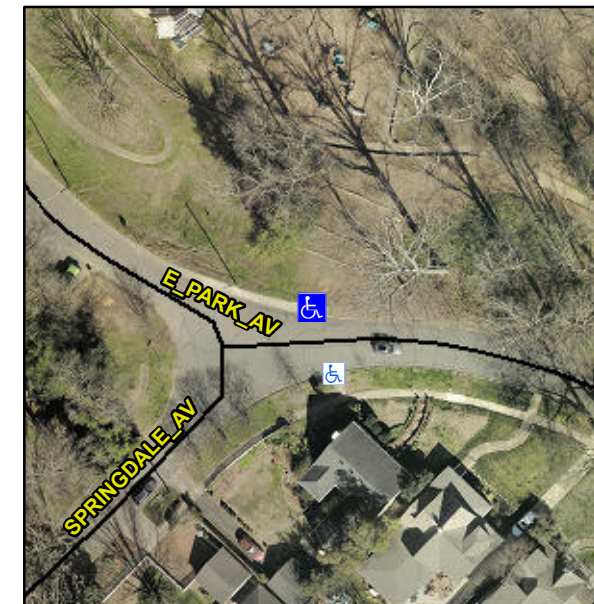
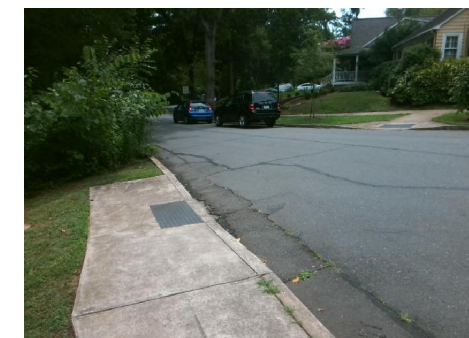
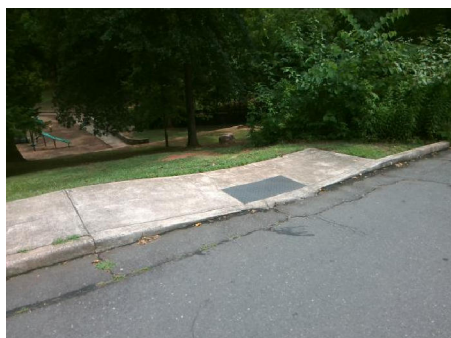
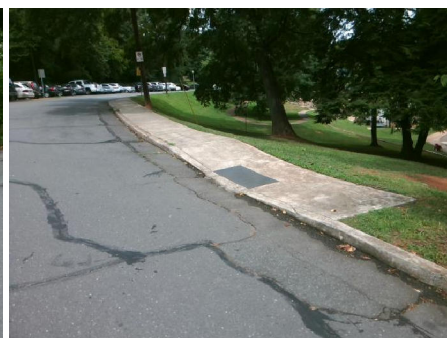
LNDG/GRADE BREAK EXISTS

Not Found, R304.5.1, R304.5.3, R304.3.2

Compliance	Description	Data	Compliance	Description	Data
N/A	Ramp Length LT (in)	76.0	N/A	Ramp Length RT (in)	N/A
No	Ramp Width LT (in)	35.0	N/A	Ramp Width RT (in)	N/A
No	Ramp Slope LT (%)	12.0	N/A	Ramp Slope RT (%)	N/A
Yes	Ramp XSlope LT (%)	0.9	N/A	Ramp XSlope RT (%)	N/A
N/A	Ramp Length (in)	24.0	Yes	Ramp Slope (%)	2.5
Yes	Ramp Width (in)	48.0	No	Ramp XSlope (%)	5.5
N/A	Flare Type LT	N/A	N/A	Flare Type RT	N/A
N/A	Flare Slope LT (%)	N/A	N/A	Flare Slope RT (%)	N/A
N/A	Flare Traversable LT?	N/A	N/A	Flare Traversable RT?	N/A
N/A	Landing Length (in)	N/A	N/A	DWS Provided?	N/A
N/A	Landing Width (in)	N/A	N/A	DWS Contrast?	N/A
N/A	Landing Slope (%)	N/A	N/A	DWS Length (in)	N/A
N/A	Landing X Slope (%)	N/A	N/A	DWS Full Width?	N/A
N/A	Landing Curb? (Y/N)	N/A	N/A	DWS Offset (in)	N/A
N/A	Shared Landing?	N/A			
N/A	Gutter Ponding?	N/A	N/A	Gutter Slope (%)	N/A
N/A	Gutter Lip Ht (in)	N/A	N/A	Gutter X Slope (%)	N/A
N/A	Painted X Walk1?	No	N/A	Painted X Walk2?	N/A

X Walk 1 Direction	To S		X Walk 2 Direction	N/A
	X Walk 1 Width (in)	N/A		X Walk 2 Width (in)	N/A
	X Walk 1 Slope (%)	4.8		X Walk 2 Slope (%)	N/A
	X Walk 1 X Slope (%)	6.1		X Walk 2 X Slope (%)	N/A
N/A	Ramp inside XWalk1?	N/A	N/A	Ramp inside XWalk2?	N/A
	Road Slope (%)	N/A		Clear Space?	N/A
	Road X Slope (%)	N/A	N/A	Clear Space to XWalk (in)	N/A
			N/A	Any Obstruction?	N/A
				Obstruction Type	N/A
			N/A	Storm Grate/Utility Hazard?	N/A
				Storm Grate/Utility Type	N/A
					N/A
Yes	Surface Condition? (G/P)	Good			
	Curb Slope (%)	9.7

Remove & Replace Entire Ramp.
