# Access Compliance Report

## Public Rights-of-Way

### (Curb Ramps)

Intersection ID: 2838	Main Street: FOGGY_MEADOW_RD	Cross Street: LONG_FOREST_DR	Location: SE
ADA ID: 18C8BF62017B	Ramp Type: Perp	Initial Pass/Fail: Fail	Overall Compliance: No
Severity Score: 13.75			
Codes/Mitigation Info/Possible Solution		Field Measurements/Component Compliance

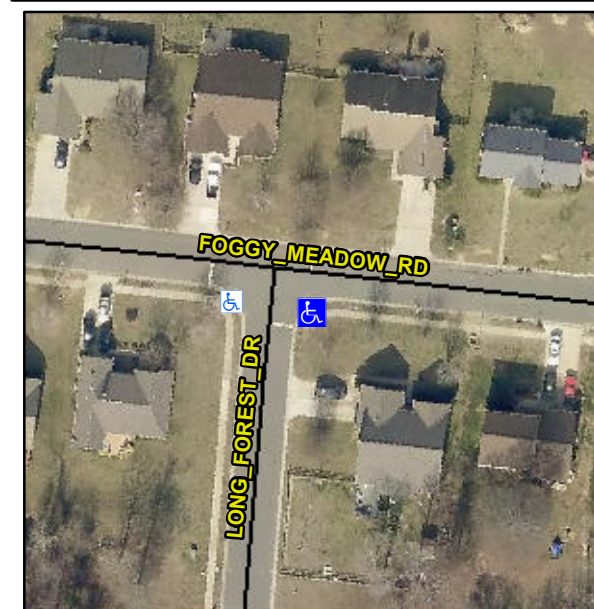
**Not Found, R304.2.2, R304.5.3**

Compliance	Description	Data	Compliance	Description	Data
N/A	Ramp Length (in)	47.0	No	Ramp Slope (%)	10.7
Yes	Ramp Width (in)	48.0	No	Ramp XSlope (%)	4.7
N/A	Flare Type LT	N/A	N/A	Flare Type RT	N/A
N/A	Flare Slope LT (%)	N/A	N/A	Flare Slope RT (%)	N/A
N/A	Flare Traversable LT?	N/A	N/A	Flare Traversable RT?	N/A
N/A	Landing Length (in)	N/A	N/A	DWS Provided?	N/A
N/A	Landing Width (in)	N/A	N/A	DWS Contrast?	N/A
N/A	Landing Slope (%)	N/A	N/A	DWS Length (in)	N/A
N/A	Landing X Slope (%)	N/A	N/A	DWS Full Width?	N/A
N/A	Landing Curb? (Y/N)	N/A	N/A	DWS Offset (in)	N/A
N/A	Shared Landing?	N/A			
N/A	Gutter Ponding?	N/A	N/A	Gutter Slope (%)	N/A
N/A	Gutter Lip Ht (in)	N/A	N/A	Gutter X Slope (%)	N/A
N/A	Painted X Walk1?	No	N/A	Painted X Walk2?	N/A
	X Walk 1 Direction	To W		X Walk 2 Direction	N/A
N/A	X Walk 1 Width (in)	N/A	N/A	X Walk 2 Width (in)	N/A
	X Walk 1 Slope (%)	4.9		X Walk 2 Slope (%)	N/A
	X Walk 1 X Slope (%)	3.8		X Walk 2 X Slope (%)	N/A

**Remove & Replace Entire Ramp.**
