Access Compliance Report

Public Rights-of-Way

(Curb Ramps)

Intersection ID: 24472	Main Street: CARMEL_RD	Cross Street: QUAIL_VIEW_RD	Location: NW
ADA ID: 18E82A30536E	Ramp Type: PerpDiag	Initial Pass/Fail: Fail	Overall Compliance: No
		Severity Score: 22.5

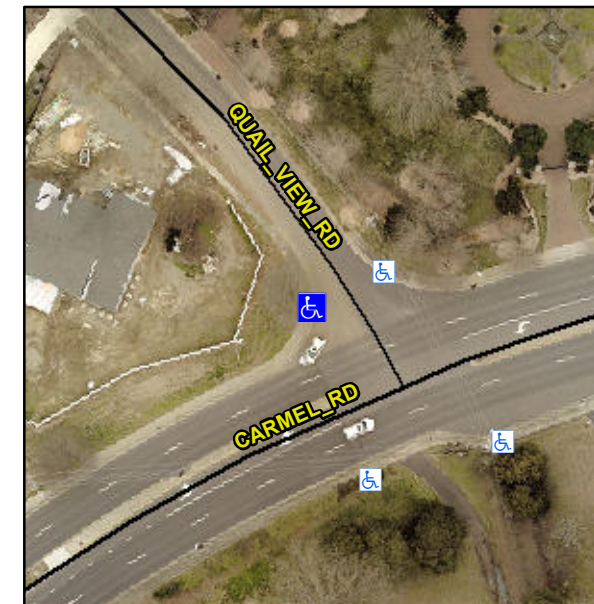
Not Found, R304.5.1, R304.2.2, R304.5.3

Compliance	Description	Data	Compliance	Description	Data
N/A	Ramp Length (in)	62.0	No	Ramp Slope (%)	10.1
No	Ramp Width (in)	38.0	No	Ramp XSlope (%)	3.6
N/A	Flare Type LT	N/A	N/A	Flare Type RT	N/A
N/A	Flare Slope LT (%)	N/A	N/A	Flare Slope RT (%)	N/A
N/A	Flare Traversable LT?	N/A	N/A	Flare Traversable RT?	N/A
N/A	Landing Length (in)	N/A	N/A	DWS Provided?	N/A
N/A	Landing Width (in)	N/A	N/A	DWS Contrast?	N/A
N/A	Landing Slope (%)	N/A	N/A	DWS Length (in)	N/A
N/A	Landing X Slope (%)	N/A	N/A	DWS Full Width?	N/A
N/A	Landing Curb? (Y/N)	N/A	N/A	DWS Offset (in)	N/A
N/A	Shared Landing?	N/A			
N/A	Gutter Ponding?	N/A	N/A	Gutter Slope (%)	N/A
N/A	Gutter Lip Ht (in)	N/A	N/A	Gutter X Slope (%)	N/A
N/A	Painted X Walk1?	No	N/A	Painted X Walk2?	No
	X Walk 1 Direction	To SE		X Walk 2 Direction	To NE
N/A	X Walk 1 Width (in)	N/A	N/A	X Walk 2 Width (in)	N/A
	X Walk 1 Slope (%)	1.9		X Walk 2 Slope (%)	1.1
	X Walk 1 X Slope (%)	2.6		X Walk 2 X Slope (%)	0.6

N/A	Ramp inside XWalk1?	N/A	N/A	Ramp inside XWalk2?	N/A
	Road Slope (%)	2.3	N/A	Clear Space?	N/A
	Road X Slope (%)	0.4	N/A	Clear Space to XWalk (in)	N/A
N/A	Any Obstructions?	N/A	N/A	Storm Grate/Utility Hazard?	N/A
	Obstruction Type			Storm Grate/Utility Type	
		N/A			N/A
			Yes	Surface Condition? (G/P)	Good

Remove & Replace Curb Ramp With Two New Directional Ramps or Equivalent.
