# Access Compliance Report

## Public Rights-of-Way

### (Curb Ramps)

Intersection ID: 4977	Main Street: CARMATHEN_RD	Cross Street: CASTLEMAINE_DR	Location: NE
ADA ID: 18E9F4F8E1AB	Ramp Type: Perp	Initial Pass/Fail: Fail	Overall Compliance: No
Severity Score: 1.25			
Codes/Mitigation Info/Possible Solution		Field Measurements/Component Compliance

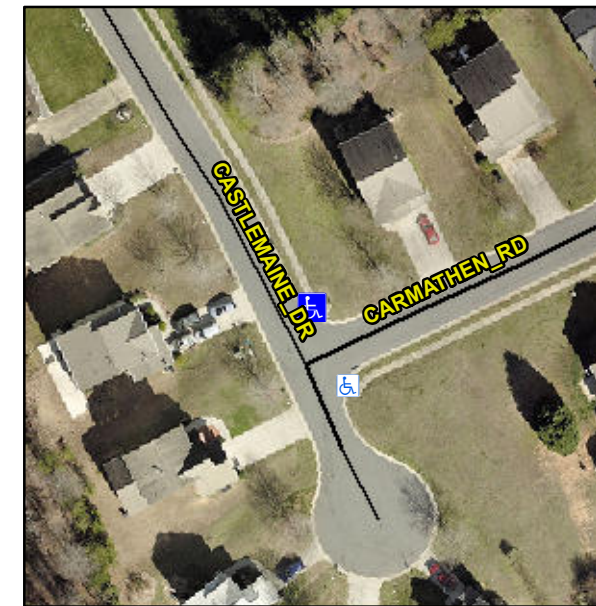
**Not Found, R304.5.3**

Compliance	Description	Data	Compliance	Description	Data
N/A	Ramp Length (in)	46.0	Yes	Ramp Slope (%)	5.2
Yes	Ramp Width (in)	50.0	No	Ramp XSlope (%)	3.4
N/A	Flare Type LT	N/A	N/A	Flare Type RT	N/A
N/A	Flare Slope LT (%)	N/A	N/A	Flare Slope RT (%)	N/A
N/A	Flare Traversable LT?	N/A	N/A	Flare Traversable RT?	N/A
N/A	Landing Length (in)	N/A	N/A	DWS Provided?	N/A
N/A	Landing Width (in)	N/A	N/A	DWS Contrast?	N/A
N/A	Landing Slope (%)	N/A	N/A	DWS Length (in)	N/A
N/A	Landing X Slope (%)	N/A	N/A	DWS Full Width?	N/A
N/A	Landing Curb? (Y/N)	N/A	N/A	DWS Offset (in)	N/A
N/A	Shared Landing?	N/A			
N/A	Gutter Ponding?	N/A	N/A	Gutter Slope (%)	N/A
N/A	Gutter Lip Ht (in)	N/A	N/A	Gutter X Slope (%)	N/A
N/A	Painted X Walk1?	No	N/A	Painted X Walk2?	N/A
	X Walk 1 Direction	To S		X Walk 2 Direction	N/A
N/A	X Walk 1 Width (in)	N/A	N/A	X Walk 2 Width (in)	N/A
	X Walk 1 Slope (%)	8.7		X Walk 2 Slope (%)	N/A
	X Walk 1 X Slope (%)	4.5		X Walk 2 X Slope (%)	N/A

N/A	Ramp inside XWalk1?	N/A	N/A	Ramp inside XWalk2?	N/A
	Road Slope (%)	N/A	N/A	Clear Space?	N/A
	Road X Slope (%)	N/A	N/A	Clear Space to XWalk (in)	N/A
N/A	Any Obstructions?	N/A	N/A	Storm Grate/Utility Hazard?	N/A
	Obstruction Type			Storm Grate/Utility Type	
		N/A			N/A
		Yes		Surface Condition? (G/P)	Good

Possible Solutions:

**Remove & Replace Entire Ramp.**

Total Cost: \$ 1850.00
