Intersection ID: 21209	Main Street: GALLERIA_BV	Cross Street: SARDIS_RD_NORTH	Location:	NW
ADA ID: 18F7AB7E8A7C	Ramp Type: Perp	Initial Pass/Fail: Fail	Overall Compliance: No	Severity Score: 21.25

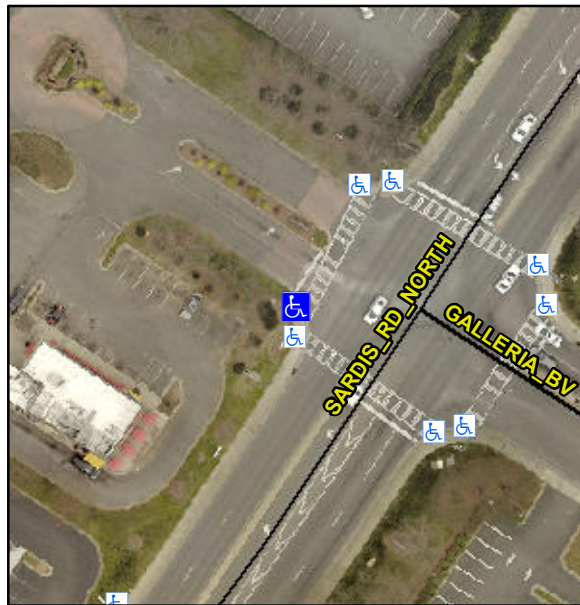
Not Found, R304.5.1, R304.5.3

Compliance	Description	Data	Compliance	Description	Data
N/A	Ramp Length (in)	70.0	Yes	Ramp Slope (%)	5.5
No	Ramp Width (in)	36.0	No	Ramp XSlope (%)	5.2
N/A	Flare Type LT	N/A	N/A	Flare Type RT	N/A
N/A	Flare Slope LT (%)	N/A	N/A	Flare Slope RT (%)	N/A
N/A	Flare Traversable LT?	N/A	N/A	Flare Traversable RT?	N/A
N/A	Landing Length (in)	N/A	N/A	DWS Provided?	N/A
N/A	Landing Width (in)	N/A	N/A	DWS Contrast?	N/A
N/A	Landing Slope (%)	N/A	N/A	DWS Length (in)	N/A
N/A	Landing X Slope (%)	N/A	N/A	DWS Full Width?	N/A
N/A	Landing Curb? (Y/N)	N/A	N/A	DWS Offset (in)	N/A
N/A	Shared Landing?	N/A			
N/A	Gutter Ponding?	N/A	N/A	Gutter Slope (%)	N/A
N/A	Gutter Lip Ht (in)	N/A	N/A	Gutter X Slope (%)	N/A
N/A	Painted X Walk1?	Yes	N/A	Painted X Walk2?	N/A
	X Walk 1 Direction	To NE		X Walk 2 Direction	N/A
N/A	X Walk 1 Width (in)	81.0	N/A	X Walk 2 Width (in)	N/A
	X Walk 1 Slope (%)	1.4		X Walk 2 Slope (%)	N/A
	X Walk 1 X Slope (%)	2.5		X Walk 2 X Slope (%)	N/A

N/A	Ramp inside XWalk1?	Yes	N/A	Ramp inside XWalk2?	N/A
	Road Slope (%)	N/A	N/A	Clear Space?	N/A
	Road X Slope (%)	N/A	N/A	Clear Space to XWalk (in)	N/A
N/A	Any Obstructions?	N/A	N/A	Storm Grate/Utility Hazard?	N/A
	Obstruction Type			Storm Grate/Utility Type	
		N/A			N/A
			Yes	Surface Condition? (G/P)	Good

Remove & Replace Entire Ramp.
