# Access Compliance Report

## Public Rights-of-Way

### (Curb Ramps)

Intersection ID: N/A	Main Street: NATIONAL_AV	Cross Street: CITY_PARK_DR	Location: E
ADA ID: 1908A3E42BAD	Ramp Type: Perp	Initial Pass/Fail: Fail	Overall Compliance: No
Severity Score: 1.25			
Codes/Mitigation Info/Possible Solution		Field Measurements/Component Compliance

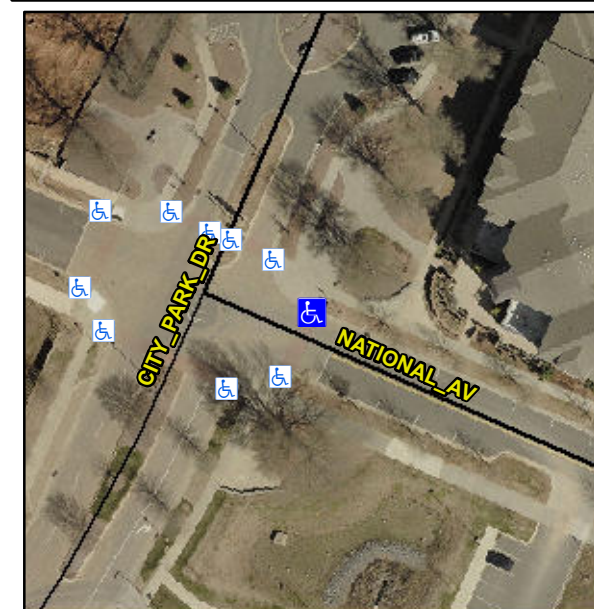
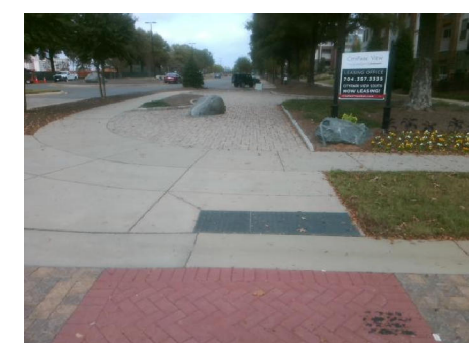
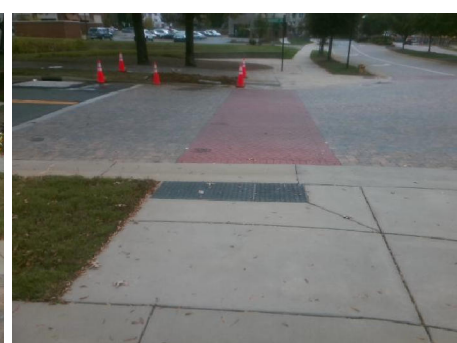
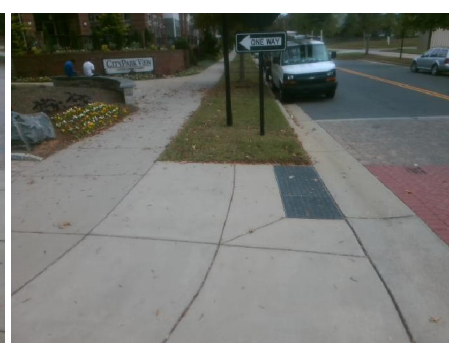
**Not Found, R304.5.3**

Compliance	Description	Data	Compliance	Description	Data
N/A	Ramp Length (in)	97.0	Yes	Ramp Slope (%)	6.7
Yes	Ramp Width (in)	74.0	No	Ramp XSlope (%)	2.4
N/A	Flare Type LT	N/A	N/A	Flare Type RT	N/A
N/A	Flare Slope LT (%)	N/A	N/A	Flare Slope RT (%)	N/A
N/A	Flare Traversable LT?	N/A	N/A	Flare Traversable RT?	N/A
N/A	Landing Length (in)	N/A	N/A	DWS Provided?	N/A
N/A	Landing Width (in)	N/A	N/A	DWS Contrast?	N/A
N/A	Landing Slope (%)	N/A	N/A	DWS Length (in)	N/A
N/A	Landing X Slope (%)	N/A	N/A	DWS Full Width?	N/A
N/A	Landing Curb? (Y/N)	N/A	N/A	DWS Offset (in)	N/A
N/A	Shared Landing?	N/A			
N/A	Gutter Ponding?	N/A	N/A	Gutter Slope (%)	N/A
N/A	Gutter Lip Ht (in)	N/A	N/A	Gutter X Slope (%)	N/A
N/A	Painted X Walk1?	Yes	N/A	Painted X Walk2?	N/A
	X Walk 1 Direction	To SW		X Walk 2 Direction	N/A
N/A	X Walk 1 Width (in)	98.0	N/A	X Walk 2 Width (in)	N/A
	X Walk 1 Slope (%)	3.8		X Walk 2 Slope (%)	N/A
	X Walk 1 X Slope (%)	2.1		X Walk 2 X Slope (%)	N/A

N/A	Ramp inside XWalk1?	Yes	N/A	Ramp inside XWalk2?	N/A
	Road Slope (%)	N/A	N/A	Clear Space?	N/A
	Road X Slope (%)	N/A	N/A	Clear Space to XWalk (in)	N/A
N/A	Any Obstructions?	N/A	N/A	Storm Grate/Utility Hazard?	N/A
	Obstruction Type			Storm Grate/Utility Type	
		N/A			N/A
		Yes		Surface Condition? (G/P)	Good

Possible Solutions:

**Remove & Replace Entire Ramp.**
