Access Compliance Report

Public Rights-of-Way (Curb Ramps)

Intersection ID: 3757	Main Street: DAVIS_LAKE_PY	Cross Street: POPLAR_GROVE_DR	Location: NE
ADA ID: 19130CEE117F	Ramp Type: Perp	Initial Pass/Fail: Fail	Overall Compliance: No
Severity Score: 22.5			
Codes/Mitigation Info/Possible Solution		Field Measurements/Component Compliance

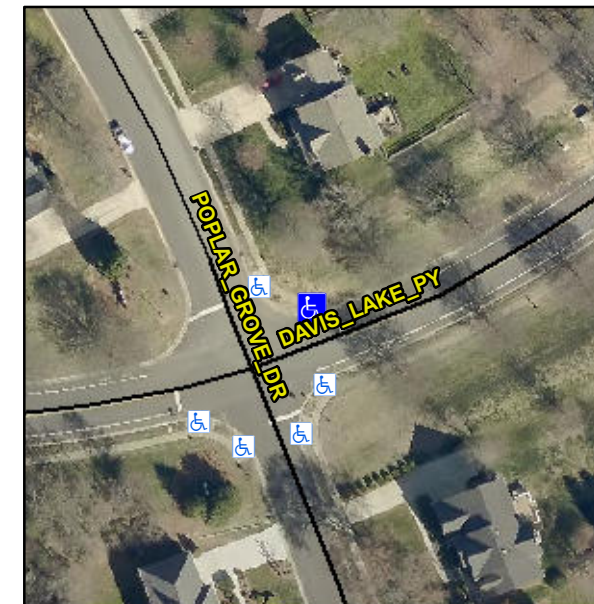
Not Found, R304.5.1, R304.2.2, R304.5.3

Compliance	Description	Data	Compliance	Description	Data
N/A	Ramp Length (in)	99.5	No	Ramp Slope (%)	8.8
No	Ramp Width (in)	40.0	No	Ramp XSlope (%)	2.6
N/A	Flare Type LT	N/A	N/A	Flare Type RT	N/A
N/A	Flare Slope LT (%)	N/A	N/A	Flare Slope RT (%)	N/A
N/A	Flare Traversable LT?	N/A	N/A	Flare Traversable RT?	N/A
N/A	Landing Length (in)	N/A	N/A	DWS Provided?	N/A
N/A	Landing Width (in)	N/A	N/A	DWS Contrast?	N/A
N/A	Landing Slope (%)	N/A	N/A	DWS Length (in)	N/A
N/A	Landing X Slope (%)	N/A	N/A	DWS Full Width?	N/A
N/A	Landing Curb? (Y/N)	N/A	N/A	DWS Offset (in)	N/A
N/A	Shared Landing?	N/A			
N/A	Gutter Ponding?	N/A	N/A	Gutter Slope (%)	N/A
N/A	Gutter Lip Ht (in)	N/A	N/A	Gutter X Slope (%)	N/A
N/A	Painted X Walk1?	No	N/A	Painted X Walk2?	N/A
	X Walk 1 Direction	To S		X Walk 2 Direction	N/A
N/A	X Walk 1 Width (in)	N/A	N/A	X Walk 2 Width (in)	N/A
	X Walk 1 Slope (%)	3.9		X Walk 2 Slope (%)	N/A
	X Walk 1 X Slope (%)	1.2		X Walk 2 X Slope (%)	N/A

Remove & Replace Entire Ramp.
