Access Compliance Report

Public Rights-of-Way

(Curb Ramps)

Intersection ID: 10037884	Main Street: SHARON_VIEW_RD	Cross Street: N/A	Location: NW
ADA ID: 192E4D080CEF	Ramp Type: PerpDiag	Initial Pass/Fail: Fail	Overall Compliance: No
Severity Score: 13.75			
Codes/Mitigation Info/Possible Solution		Field Measurements/Component Compliance

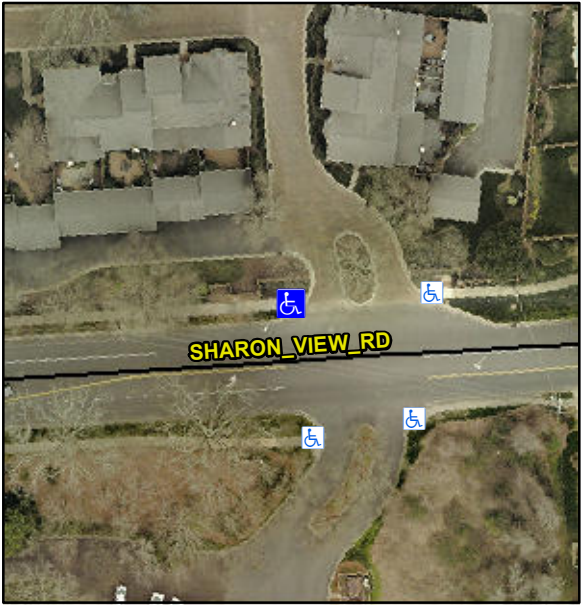
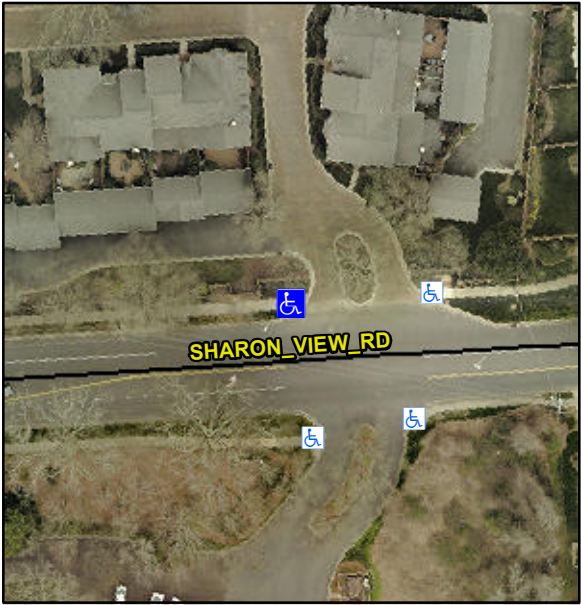
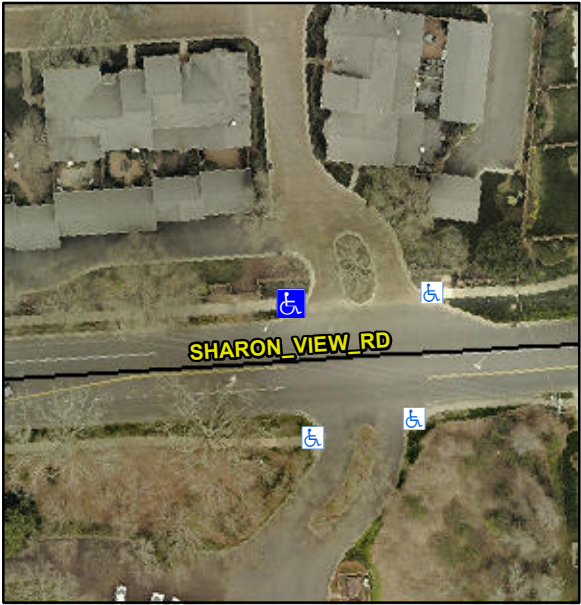
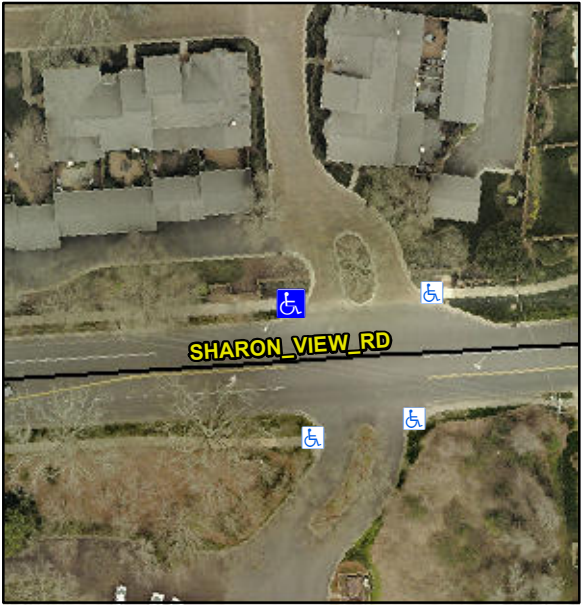
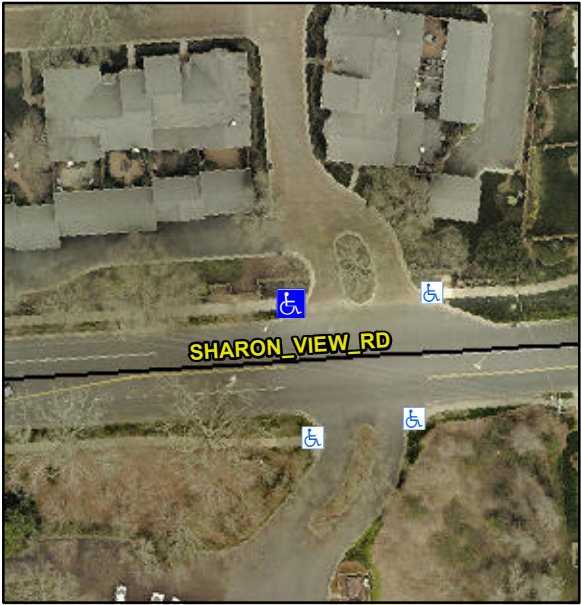
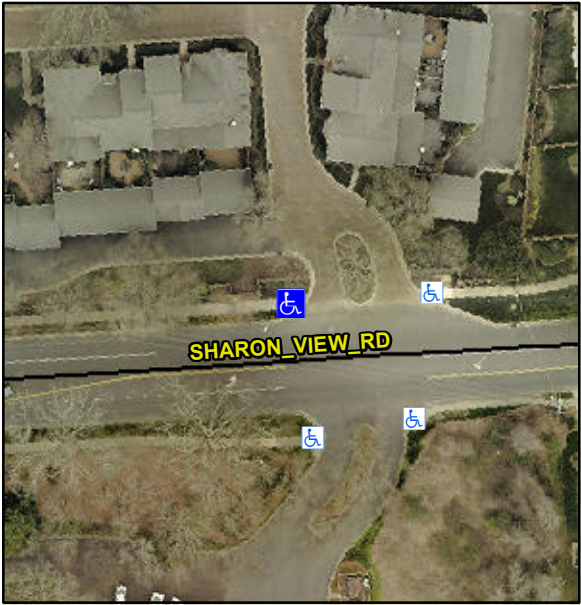
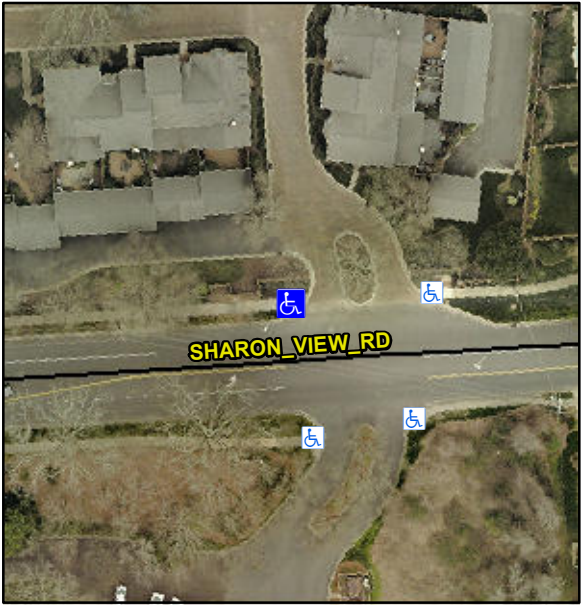
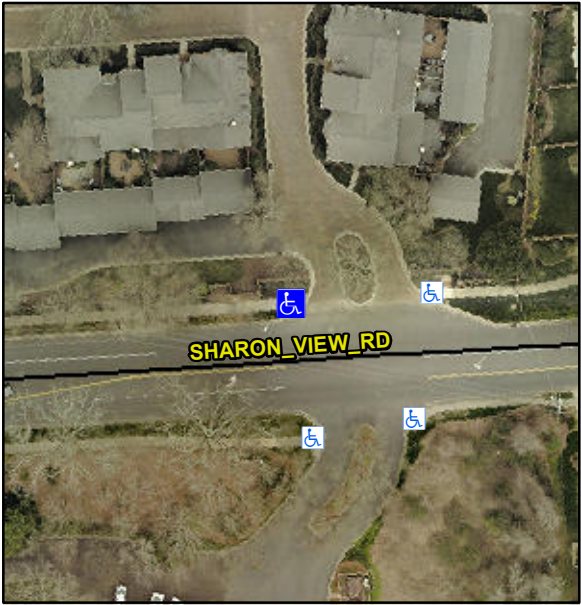
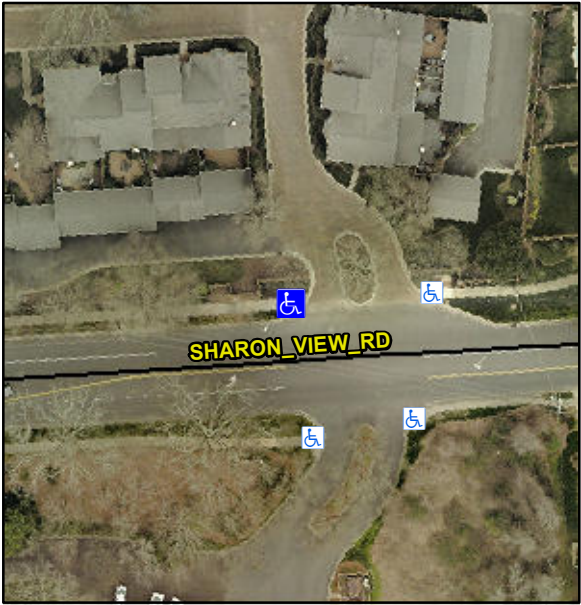
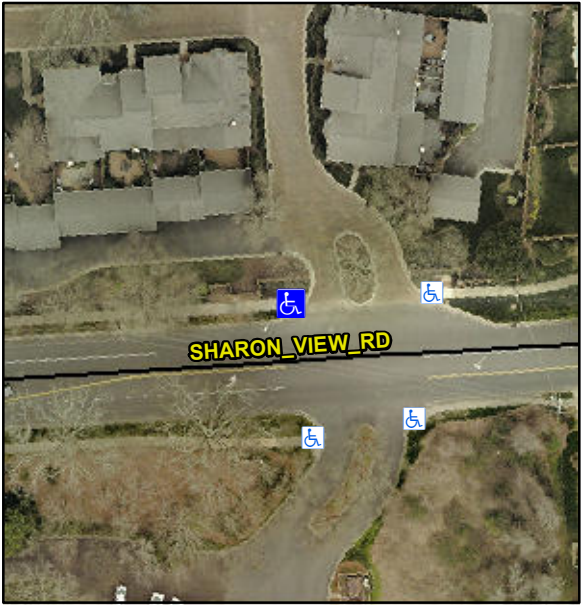
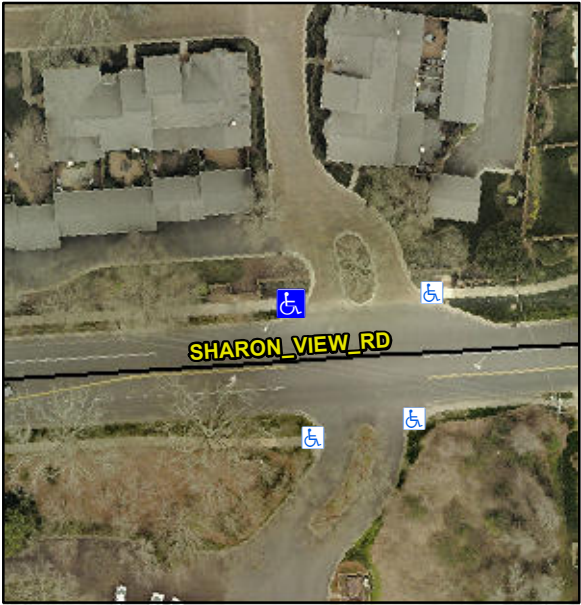
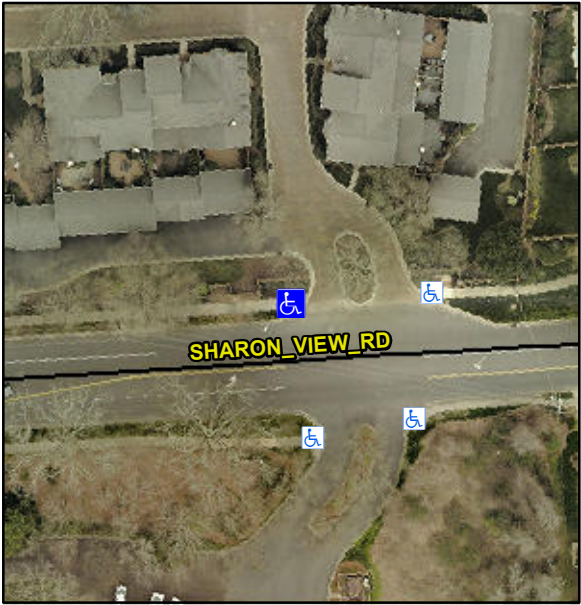
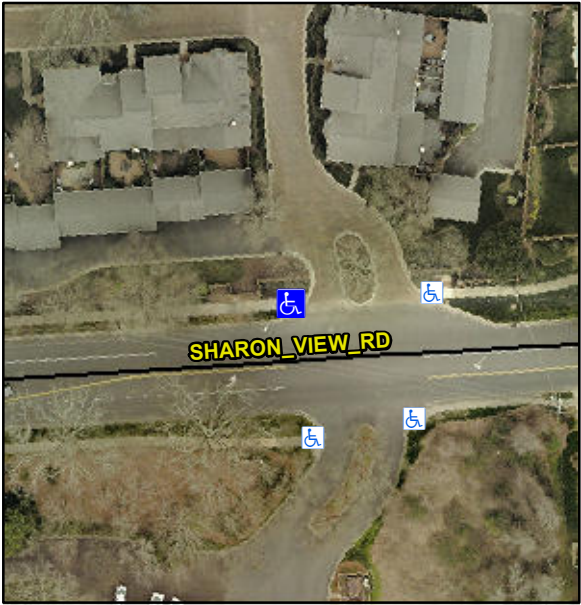
Possible Solutions:		Compliance		Description		Data	Compliance	Description	Data
	Remove & Replace Curb Ramp With Two New Directional Ramps or Equivalent.		N/A		Ramp Length (in)		50.0	No	Ramp Slope (%)	9.1

Surveyor Notes:		Yes		Ramp Width (in)		48.0	No	Ramp XSlope (%)	2.8
	N/A		N/A		Flare Type LT		N/A	N/A	Flare Type RT	N/A

PROW/ADA:		N/A		Flare Slope LT (%)		N/A	N/A	Flare Slope RT (%)	N/A
	Not Found, R304.2.2, R304.5.3		N/A		Flare Traversable LT?		N/A	N/A	Flare Traversable RT?	N/A
