Access Compliance Report

Public Rights-of-Way

(Curb Ramps)

Intersection ID: 15138	Main Street: FENTON_PL	Cross Street: HEMPSTEAD_PL	Location: E
ADA ID: 1933079E19C7	Ramp Type: Perp	Initial Pass/Fail: Fail	Overall Compliance: No
Severity Score: 12.5			
Codes/Mitigation Info/Possible Solution		Field Measurements/Component Compliance

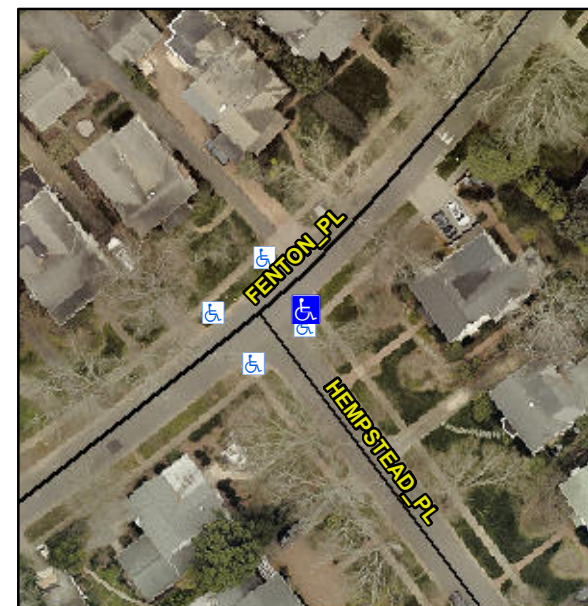
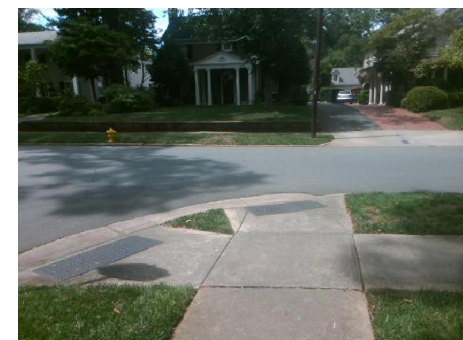
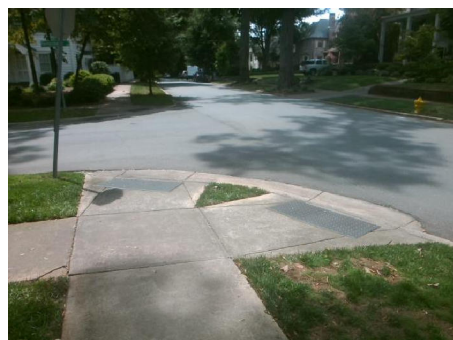
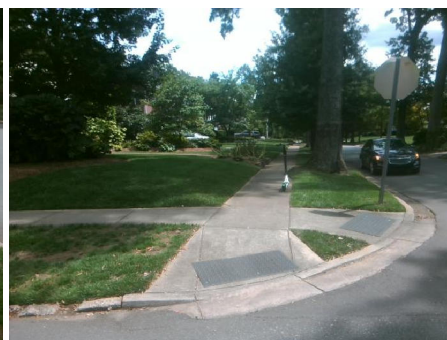
PROW/ADA:

R304.2.2

Compliance	Description	Data	Compliance	Description	Data
N/A	Ramp Length (in)	60.0	No	Ramp Slope (%)	9.9
Yes	Ramp Width (in)	54.0	Yes	Ramp XSlope (%)	1.4
N/A	Flare Type LT	N/A	N/A	Flare Type RT	N/A
N/A	Flare Slope LT (%)	N/A	N/A	Flare Slope RT (%)	N/A
N/A	Flare Traversable LT?	N/A	N/A	Flare Traversable RT?	N/A
N/A	Landing Length (in)	N/A	N/A	DWS Provided?	N/A
N/A	Landing Width (in)	N/A	N/A	DWS Contrast?	N/A
N/A	Landing Slope (%)	N/A	N/A	DWS Length (in)	N/A
N/A	Landing X Slope (%)	N/A	N/A	DWS Full Width?	N/A
N/A	Landing Curb? (Y/N)	N/A	N/A	DWS Offset (in)	N/A
N/A	Shared Landing?	N/A			
N/A	Gutter Ponding?	N/A	N/A	Gutter Slope (%)	N/A
N/A	Gutter Lip Ht (in)	N/A	N/A	Gutter X Slope (%)	N/A
N/A	Painted X Walk1?	No	N/A	Painted X Walk2?	N/A
	X Walk 1 Direction	To NW		X Walk 2 Direction	N/A
N/A	X Walk 1 Width (in)	N/A	N/A	X Walk 2 Width (in)	N/A
	X Walk 1 Slope (%)	2.6		X Walk 2 Slope (%)	N/A
	X Walk 1 X Slope (%)	2.5		X Walk 2 X Slope (%)	N/A

N/A	Ramp inside XWalk1?	N/A	N/A	Ramp inside XWalk2?	N/A
	Road Slope (%)	N/A	N/A	Clear Space?	N/A
	Road X Slope (%)	N/A	N/A	Clear Space to XWalk (in)	N/A
N/A	Any Obstructions?	N/A	N/A	Storm Grate/Utility Hazard?	N/A
	Obstruction Type			Storm Grate/Utility Type	
		N/A			N/A
			Yes	Surface Condition? (G/P)	Good

Possible Solutions:

Remove & Replace Entire Ramp.

Total Cost: \$ 1850.00
