# Access Compliance Report

## Public Rights-of-Way

### (Curb Ramps)

Intersection ID: 11597	Main Street: E_20TH_ST	Cross Street: SEIGLE_AV	Location:	N
ADA ID: 1934AFED6A68	Ramp Type: Perp	Initial Pass/Fail: Fail	Overall Compliance: No	Severity Score: 37.5

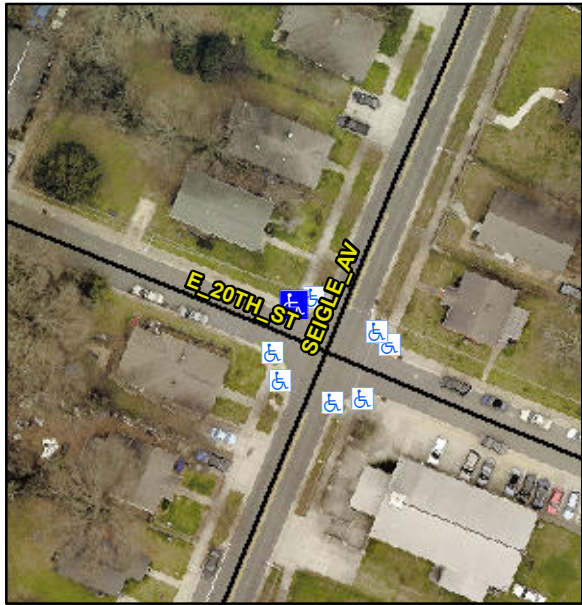
Possible Solutions:		Compliance	Description	Data	Compliance	Description	Data
	Remove & Replace Entire Ramp.		N/A	Ramp Length (in)	61.0	No	Ramp Slope (%)	13.0
			Yes	Ramp Width (in)	48.0	No	Ramp XSlope (%)	5.6
			N/A	Flare Type LT	N/A	N/A	Flare Type RT	N/A
			N/A	Flare Slope LT (%)	N/A	N/A	Flare Slope RT (%)	N/A
			N/A	Flare Traversable LT?	N/A	N/A	Flare Traversable RT?	N/A
			N/A	Landing Length (in)	N/A	N/A	DWS Provided?	N/A
			N/A	Landing Width (in)	N/A	N/A	DWS Contrast?	N/A
			N/A	Landing Slope (%)	N/A	N/A	DWS Length (in)	N/A
			N/A	Landing X Slope (%)	N/A	N/A	DWS Full Width?	N/A
Surveyor Notes:		N/A	N/A	Landing Curb? (Y/N)	N/A	N/A	DWS Offset (in)	N/A
PROW/ADA:		Not Found, R304.2.2, R304.5.3	N/A	Shared Landing?	N/A	N/A	Gutter Slope (%)	N/A
			N/A	Gutter Ponding?	N/A	N/A	Gutter X Slope (%)	N/A
			N/A	Gutter Lip Ht (in)	N/A	N/A	Gutter X Slope (%)	N/A

N/A	Painted X Walk1?	No	N/A	Painted X Walk2?	N/A
				X Walk 1 Direction	To SW		X Walk 2 Direction	N/A
			N/A	X Walk 1 Width (in)	N/A	N/A	X Walk 2 Width (in)	N/A
				X Walk 1 Slope (%)	4.4		X Walk 2 Slope (%)	N/A
				X Walk 1 X Slope (%)	5.4		X Walk 2 X Slope (%)	N/A
			N/A	Ramp inside XWalk1?	N/A	N/A	Ramp inside XWalk2?	N/A
				Road Slope (%)	N/A	N/A	Clear Space?	N/A
				Road X Slope (%)	N/A	N/A	Clear Space to XWalk (in)	N/A
			N/A	Any Obstructions?	N/A	N/A	Storm Grate/Utility Hazard?	N/A
				Obstruction Type			Storm Grate/Utility Type	
					N/A			N/A
						Yes	Surface Condition? (G/P)	Good
Total Cost:		\$ 1850.00						
Street 1 Name		E 20TH ST						
Stop Condition-Street 2		StopSign						
Street 2 Name		N/A						
Stop Condition-Street 1		N/A
