Access Compliance Report

Public Rights-of-Way

(Curb Ramps)

Intersection ID: 31392	Main Street: COVINGTONWOOD_DR	Cross Street: POINTER_RIDGE_DR	Location: W
ADA ID: 193638A862E6	Ramp Type: BlendTrans1	Initial Pass/Fail: Fail	Overall Compliance: No
Severity Score: 8.75			
Codes/Mitigation Info/Possible Solution		Field Measurements/Component Compliance

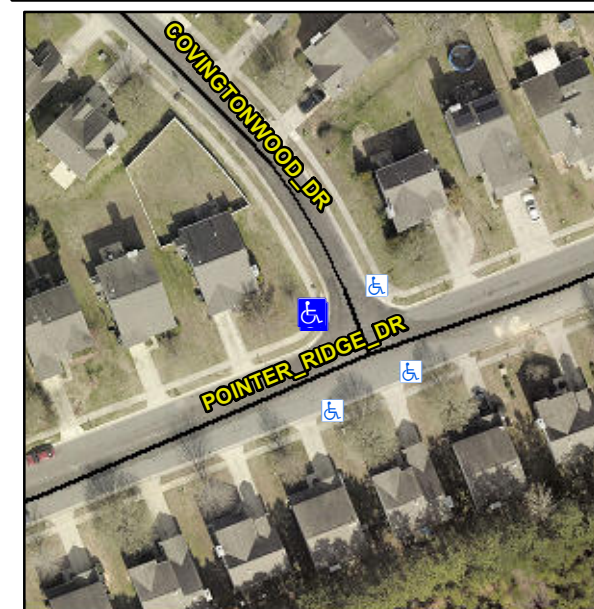
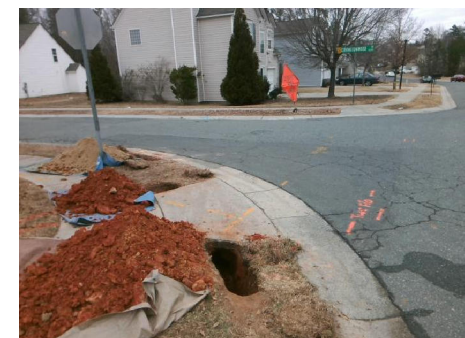
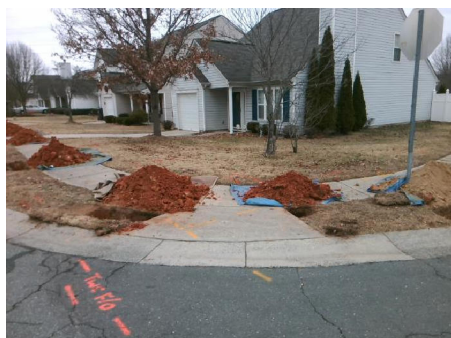
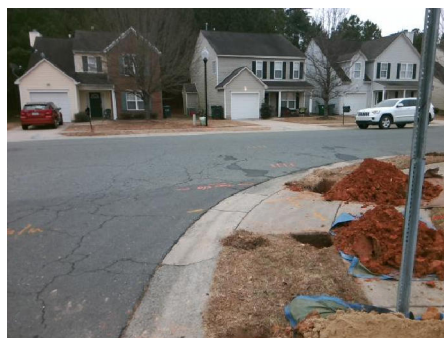
R304.5.1

Compliance	Description	Data	Compliance	Description	Data
N/A	Ramp Length (in)	48.0	Yes	BlendTrans Slope (%)	2.8
No	Ramp Width (in)	40.0	Yes	BlendTrans XSlope (%)	0.6
N/A	Flare Type LT	N/A	N/A	Flare Type RT	N/A
N/A	Flare Slope LT (%)	N/A	N/A	Flare Slope RT (%)	N/A
N/A	Flare Traversable LT?	N/A	N/A	Flare Traversable RT?	N/A
N/A	Landing Length (in)	N/A	N/A	DWS Provided?	N/A
N/A	Landing Width (in)	N/A	N/A	DWS Contrast?	N/A
N/A	Landing Slope (%)	N/A	N/A	DWS Length (in)	N/A
N/A	Landing X Slope (%)	N/A	N/A	DWS Full Width?	N/A
N/A	Landing Curb? (Y/N)	N/A	N/A	DWS Offset (in)	N/A
N/A	Shared Landing?	N/A			
N/A	Gutter Ponding?	N/A	N/A	Gutter Slope (%)	N/A
N/A	Gutter Lip Ht (in)	N/A	N/A	Gutter X Slope (%)	N/A
N/A	Painted X Walk1?	No	N/A	Painted X Walk2?	No
	X Walk 1 Direction	To SE		X Walk 2 Direction	To NE
	X Walk 1 Width (in)	N/A		X Walk 2 Width (in)	N/A
	X Walk 1 Slope (%)	4.6		X Walk 2 Slope (%)	2.9
	X Walk 1 X Slope (%)	0.0		X Walk 2 X Slope (%)	1.5

N/A	Ramp inside XWalk1?	N/A	N/A	Ramp inside XWalk2?	N/A
	Road Slope (%)	0.9		Clear Space?	N/A
	Road X Slope (%)	1.3	N/A	Clear Space to XWalk (in)	N/A
N/A	Any Obstructions?	N/A	N/A	Storm Grate/Utility Hazard?	N/A
	Obstruction Type			Storm Grate/Utility Type	
		N/A			N/A
			Yes	Surface Condition? (G/P)	Good
			N/A	Curb Slope (%)	2.0

Remove & Replace Curb Ramp With Two New Directional Ramps or Equivalent.
