Access Compliance Report

Public Rights-of-Way

(Curb Ramps)

Intersection ID: 31122	Main Street: MILLSTREAM RIDGE DR	Cross Street: N/A	Location: SE
ADA ID: 193D685C8932	Ramp Type: BlendTrans1	Initial Pass/Fail: Fail	Overall Compliance: No
			Severity Score: 21.25

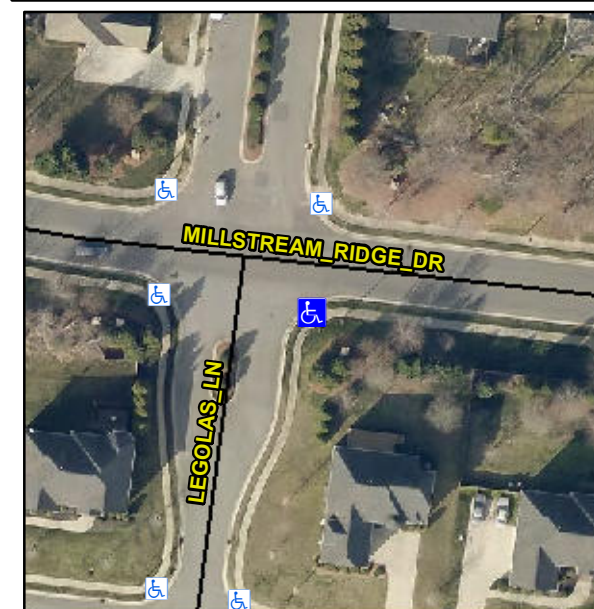
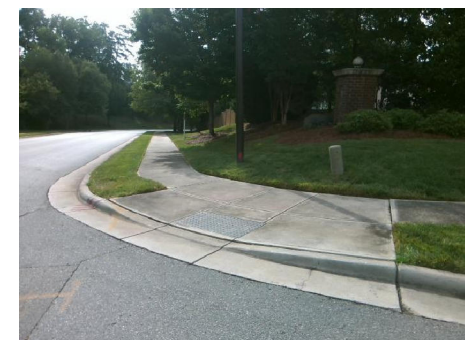
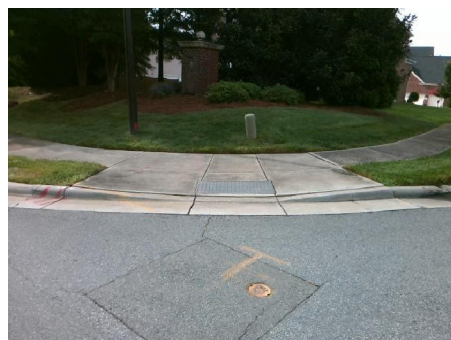
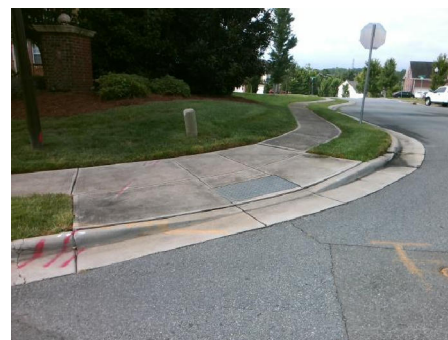
CURB GAP 1.0

R304.5.1, R304.5.3

Compliance	Description	Data	Compliance	Description	Data
N/A	Ramp Length (in)	49.0	Yes	BlendTrans Slope (%)	3.1
No	Ramp Width (in)	42.0	No	BlendTrans XSlope (%)	6.9
N/A	Flare Type LT	N/A	N/A	Flare Type RT	N/A
N/A	Flare Slope LT (%)	N/A	N/A	Flare Slope RT (%)	N/A
N/A	Flare Traversable LT?	N/A	N/A	Flare Traversable RT?	N/A
N/A	Landing Length (in)	N/A	N/A	DWS Provided?	N/A
N/A	Landing Width (in)	N/A	N/A	DWS Contrast?	N/A
N/A	Landing Slope (%)	N/A	N/A	DWS Length (in)	N/A
N/A	Landing X Slope (%)	N/A	N/A	DWS Full Width?	N/A
N/A	Landing Curb? (Y/N)	N/A	N/A	DWS Offset (in)	N/A
N/A	Shared Landing?	N/A			
N/A	Gutter Ponding?	N/A	N/A	Gutter Slope (%)	N/A
N/A	Gutter Lip Ht (in)	0.75	N/A	Gutter X Slope (%)	N/A
N/A	Painted X Walk1?	No	N/A	Painted X Walk2?	No
	X Walk 1 Direction	To N		X Walk 2 Direction	To W
	X Walk 1 Width (in)	N/A		X Walk 2 Width (in)	N/A
	X Walk 1 Slope (%)	2.4		X Walk 2 Slope (%)	6.1
	X Walk 1 X Slope (%)	3.9		X Walk 2 X Slope (%)	0.7

N/A	Ramp inside XWalk1?	N/A	N/A	Ramp inside XWalk2?	N/A
	Road Slope (%)	7.3		Clear Space?	N/A
	Road X Slope (%)	0.6	N/A	Clear Space to XWalk (in)	N/A
N/A	Any Obstructions?	N/A	N/A	Storm Grate/Utility Hazard?	N/A
	Obstruction Type			Storm Grate/Utility Type	
		N/A			N/A
			Yes	Surface Condition? (G/P)	Good
			N/A	Curb Slope (%)	N/A

Remove & Replace Curb Ramp With Two New Directional Ramps or Equivalent.
