Access Compliance Report Public Rights-of-Way (Curb Ramps)

| Intersection ID: 10041431 Main Street: WESTINGHOUSE_BV | | | Cross | Street: | N/A | Location: | NW | | |
| ADA ID: 19537C7033D6 | ADA ID: 19537C7033D6 Ramp Type: PerpDiag | | | nitial Pass/Fail: Fail Overall Compliance: No | | | | o Severity Score: | 22.5 |

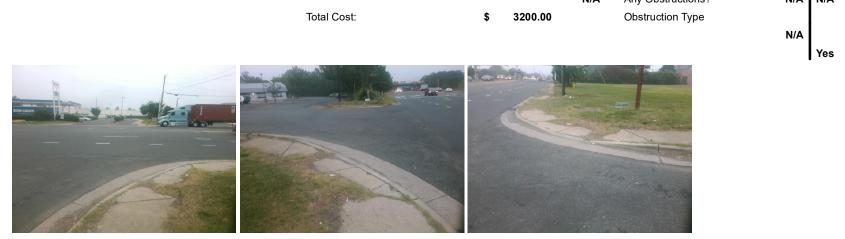
| Intersection ID: 10041431 Main Street: WESTINGHOUSE_BV | | | Cross | Street: | N/A | Location: | NW | | |
|--|--|---|---|---|---|---|---|---|---|
| | A Property | Remove & Replace Curb Ramp | With | N/A | Ramp Length (in) | 58.0 | No | Ramp Slope (%) | 9.9 |
| a state of the second | 1 XXX | Two New Directional Ramps or | | No | Ramp Width (in) | 45.0 | No | Ramp XSlope (%) | 3.0 |
| PROW/ADA: Not Found, R304.5.1, R304.2.2, R304.5.3 | | | | N/A | Landing X Slope (%) | N/A | N/A | DWS Full Width? | N/A |

| Intersection ID: 10041431 Main Street: WESTINGHOUSE_BV | | | Cross | Street: | N/A | Location: | NW | | |
|--|--|---|---|---|---|---|---|---|---|
| | 1 22 | Equivalent. | | N/A | Flare Type LT | N/A | N/A | Flare Type RT | N/A |
| | | Total Cost: \$ | 3200.00 | | Obstruction Type | | | Storm Grate/Utility Type | |
