# Access Compliance Report

## Public Rights-of-Way

### (Curb Ramps)

Intersection ID: 22449	Main Street: ST_JOHN_LN	Cross Street: SHARON_HILLS_RD	Location: NE
ADA ID: 1967AC08C7BC	Ramp Type: PerpDiag	Initial Pass/Fail: Fail	Overall Compliance: No
		Severity Score: 10

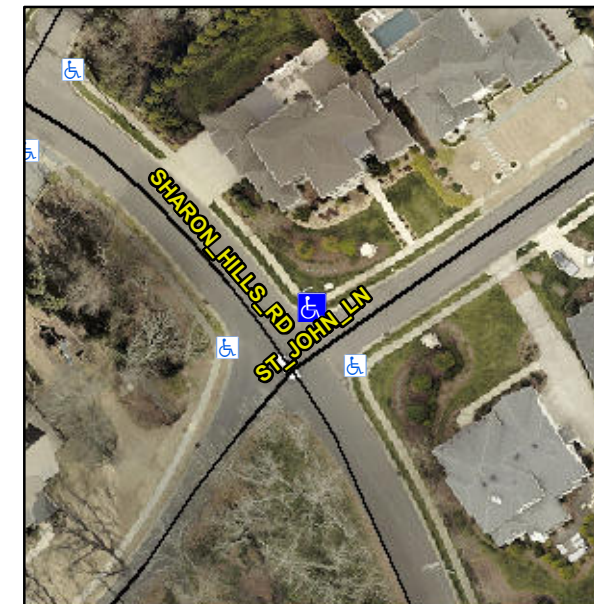
**Not Found, R304.5.1, R304.5.3**

Compliance	Description	Data	Compliance	Description	Data
N/A	Ramp Length (in)	97.0	Yes	Ramp Slope (%)	7.3
No	Ramp Width (in)	47.0	No	Ramp XSlope (%)	2.8
N/A	Flare Type LT	N/A	N/A	Flare Type RT	N/A
N/A	Flare Slope LT (%)	N/A	N/A	Flare Slope RT (%)	N/A
N/A	Flare Traversable LT?	N/A	N/A	Flare Traversable RT?	N/A
N/A	Landing Length (in)	N/A	N/A	DWS Provided?	N/A
N/A	Landing Width (in)	N/A	N/A	DWS Contrast?	N/A
N/A	Landing Slope (%)	N/A	N/A	DWS Length (in)	N/A
N/A	Landing X Slope (%)	N/A	N/A	DWS Full Width?	N/A
N/A	Landing Curb? (Y/N)	N/A	N/A	DWS Offset (in)	N/A
N/A	Shared Landing?	N/A			
N/A	Gutter Ponding?	N/A	N/A	Gutter Slope (%)	N/A
N/A	Gutter Lip Ht (in)	0.5	N/A	Gutter X Slope (%)	N/A
N/A	Painted X Walk1?	No	N/A	Painted X Walk2?	No
	X Walk 1 Direction	To W		X Walk 2 Direction	To S
N/A	X Walk 1 Width (in)	N/A	N/A	X Walk 2 Width (in)	N/A
	X Walk 1 Slope (%)	1.8		X Walk 2 Slope (%)	2.5
	X Walk 1 X Slope (%)	4.1		X Walk 2 X Slope (%)	1.6

N/A	Ramp inside XWalk1?	N/A	N/A	Ramp inside XWalk2?	N/A
	Road Slope (%)	0.9	N/A	Clear Space?	N/A
	Road X Slope (%)	4.2	N/A	Clear Space to XWalk (in)	N/A
N/A	Any Obstructions?	N/A	N/A	Storm Grate/Utility Hazard?	N/A
	Obstruction Type			Storm Grate/Utility Type	
		N/A			N/A
			Yes	Surface Condition? (G/P)	Good

**Remove & Replace Curb Ramp With Two New Directional Ramps or Equivalent.**
