# Access Compliance Report

## Public Rights-of-Way

### (Curb Ramps)

Intersection ID: 11597	Main Street: E_20TH_ST	Cross Street: SEIGLE_AV	Location:	N
ADA ID: 196B514AFABA	Ramp Type: Perp	Initial Pass/Fail: Fail	Overall Compliance: No	Severity Score: 25

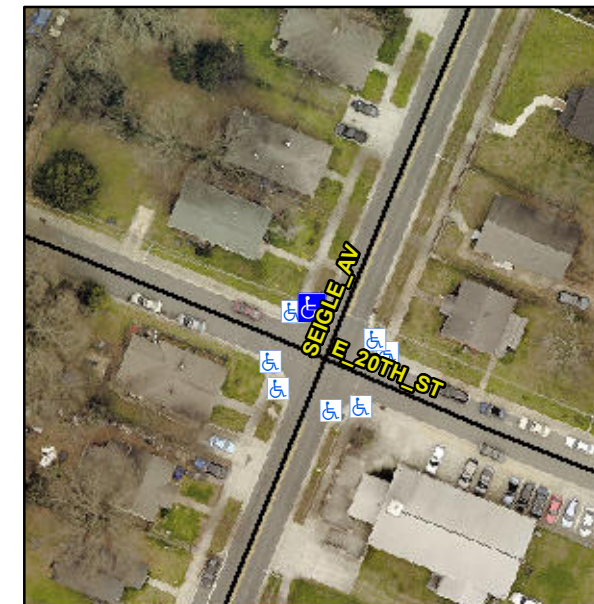
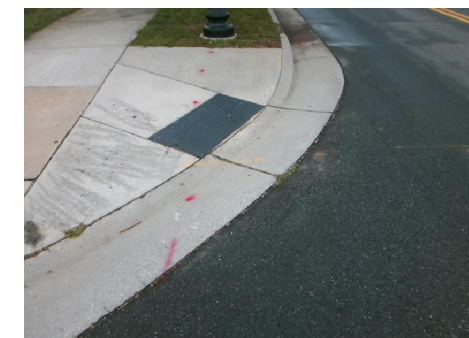
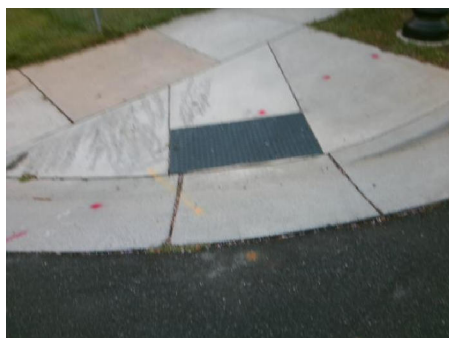
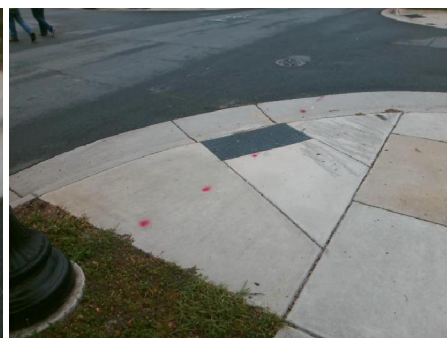
**Not Found, R304.2.2, R304.5.3**

Compliance	Description	Data	Compliance	Description	Data
N/A	Ramp Length (in)	59.5	No	Ramp Slope (%)	8.5
Yes	Ramp Width (in)	48.0	No	Ramp XSlope (%)	6.0
N/A	Flare Type LT	N/A	N/A	Flare Type RT	N/A
N/A	Flare Slope LT (%)	N/A	N/A	Flare Slope RT (%)	N/A
N/A	Flare Traversable LT?	N/A	N/A	Flare Traversable RT?	N/A
N/A	Landing Length (in)	N/A	N/A	DWS Provided?	N/A
N/A	Landing Width (in)	N/A	N/A	DWS Contrast?	N/A
N/A	Landing Slope (%)	N/A	N/A	DWS Length (in)	N/A
N/A	Landing X Slope (%)	N/A	N/A	DWS Full Width?	N/A
N/A	Landing Curb? (Y/N)	N/A	N/A	DWS Offset (in)	N/A
N/A	Shared Landing?	N/A			
N/A	Gutter Ponding?	N/A	N/A	Gutter Slope (%)	N/A
N/A	Gutter Lip Ht (in)	N/A	N/A	Gutter X Slope (%)	N/A
N/A	Painted X Walk1?	No	N/A	Painted X Walk2?	N/A
	X Walk 1 Direction	To SE		X Walk 2 Direction	N/A
N/A	X Walk 1 Width (in)	N/A	N/A	X Walk 2 Width (in)	N/A
	X Walk 1 Slope (%)	0.0		X Walk 2 Slope (%)	N/A
	X Walk 1 X Slope (%)	3.2		X Walk 2 X Slope (%)	N/A

N/A	Ramp inside XWalk1?	N/A	N/A	Ramp inside XWalk2?	N/A
	Road Slope (%)	N/A	N/A	Clear Space?	N/A
	Road X Slope (%)	N/A	N/A	Clear Space to XWalk (in)	N/A
N/A	Any Obstructions?	N/A	N/A	Storm Grate/Utility Hazard?	N/A
	Obstruction Type			Storm Grate/Utility Type	
		N/A			N/A
			Yes	Surface Condition? (G/P)	Good

**Remove & Replace Entire Ramp.**

Total Cost: \$ 1850.00
