Access Compliance Report

Public Rights-of-Way

(Curb Ramps)

Intersection ID: 30541	Main Street: GREENWAY_BEND_DR	Cross Street: SUMMERHILL_RIDGE_DR	Location: E
ADA ID: 19818BE0A8D5	Ramp Type: BlendTrans1	Initial Pass/Fail: Fail	Overall Compliance: No
		Severity Score: 8.75

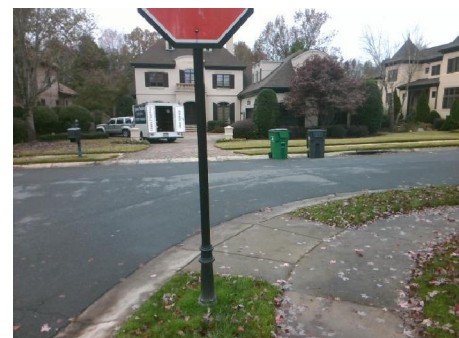
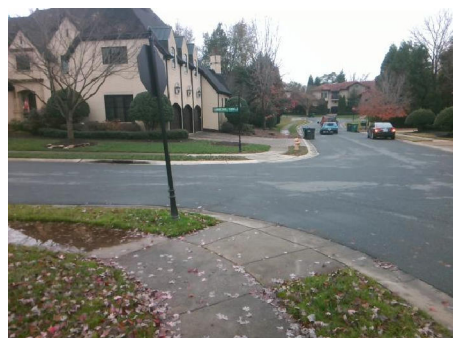
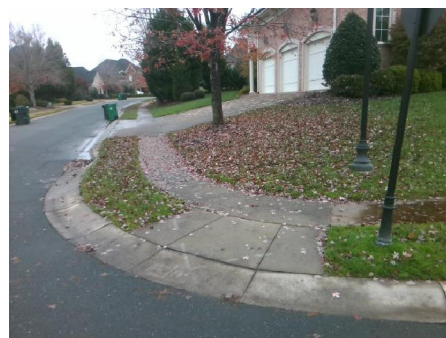
Not Found, R304.5.1

Compliance	Description	Data	Compliance	Description	Data
N/A	Ramp Length (in)	48.0	Yes	BlendTrans Slope (%)	3.7
No	Ramp Width (in)	36.0	Yes	BlendTrans XSlope (%)	1.7
N/A	Flare Type LT	N/A	N/A	Flare Type RT	N/A
N/A	Flare Slope LT (%)	N/A	N/A	Flare Slope RT (%)	N/A
N/A	Flare Traversable LT?	N/A	N/A	Flare Traversable RT?	N/A
N/A	Landing Length (in)	N/A	N/A	DWS Provided?	N/A
N/A	Landing Width (in)	N/A	N/A	DWS Contrast?	N/A
N/A	Landing Slope (%)	N/A	N/A	DWS Length (in)	N/A
N/A	Landing X Slope (%)	N/A	N/A	DWS Full Width?	N/A
N/A	Landing Curb? (Y/N)	N/A	N/A	DWS Offset (in)	N/A
N/A	Shared Landing?	N/A			
N/A	Gutter Ponding?	N/A	N/A	Gutter Slope (%)	N/A
N/A	Gutter Lip Ht (in)	N/A	N/A	Gutter X Slope (%)	N/A
N/A	Painted X Walk1?	No	N/A	Painted X Walk2?	No
	X Walk 1 Direction	To NW		X Walk 2 Direction	To SW
	X Walk 1 Width (in)	N/A		X Walk 2 Width (in)	N/A
	X Walk 1 Slope (%)	2.0		X Walk 2 Slope (%)	1.9
	X Walk 1 X Slope (%)	1.8		X Walk 2 X Slope (%)	1.5

N/A	Ramp inside XWalk1?	N/A	N/A	Ramp inside XWalk2?	N/A
	Road Slope (%)	0.8		Clear Space?	N/A
	Road X Slope (%)	0.2	N/A	Clear Space to XWalk (in)	N/A
N/A	Any Obstructions?	N/A	N/A	Storm Grate/Utility Hazard?	N/A
	Obstruction Type			Storm Grate/Utility Type	
		N/A			N/A
			Yes	Surface Condition? (G/P)	Good
			No	Curb Slope (%)	6.4

Remove & Replace Curb Ramp With Two New Directional Ramps or Equivalent.
