# Access Compliance Report

## Public Rights-of-Way

### (Curb Ramps)

Intersection ID: 23333	Main Street: SHARON_RD_WEST	Cross Street: REGENT_PARK_LN	Location: NW
ADA ID: 199715C4AE9C	Ramp Type: Perp	Initial Pass/Fail: Fail	Overall Compliance: No
			Severity Score: 13.75

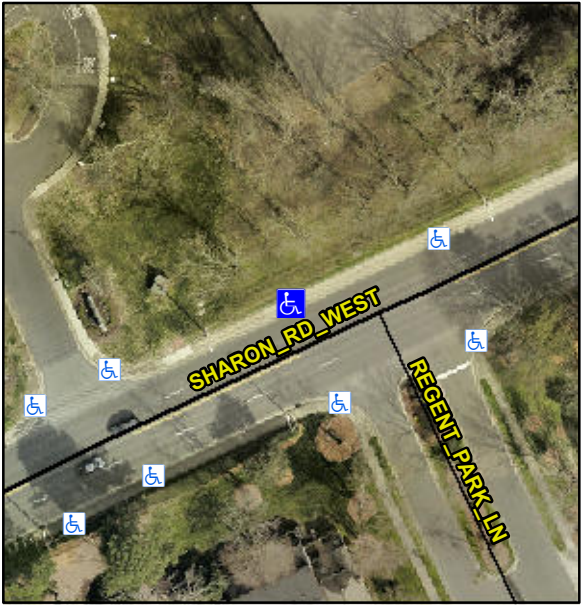
Possible Solutions:		<b>Compliance</b>	<b>Description</b>	<b>Data</b>
	<b>Remove &amp; Replace Entire Ramp.</b>		<b>No</b>	Ramp Length (in)	<b>62.0</b>
			<b>Yes</b>	Ramp Width (in)	<b>61.0</b>
			<b>N/A</b>	Flare Type LT	<b>N/A</b>
			<b>N/A</b>	Flare Slope LT (%)	<b>N/A</b>
			<b>N/A</b>	Flare Traversable LT?	<b>N/A</b>
			<b>N/A</b>	Landing Length (in)	<b>N/A</b>
			<b>N/A</b>	Landing Width (in)	<b>N/A</b>
			<b>N/A</b>	Landing Slope (%)	<b>N/A</b>
			<b>N/A</b>	Landing X Slope (%)	<b>N/A</b>
<p>Surveyor Notes:</p> <p><b>N/A</b></p> <p>PROW/ADA:</p> <p><b>Not Found, R304.2.2</b></p>			<b>N/A</b>	Flare Type RT	<b>N/A</b>
			<b>N/A</b>	Flare Slope RT (%)	<b>N/A</b>
			<b>N/A</b>	Flare Traversable RT?	<b>N/A</b>
			<b>N/A</b>	DWS Provided?	<b>N/A</b>
			<b>N/A</b>	DWS Contrast?	<b>N/A</b>
			<b>N/A</b>	DWS Length (in)	<b>N/A</b>

<b>N/A</b>	DWS Full Width?	<b>N/A</b>
			<b>N/A</b>	DWS Offset (in)	<b>N/A</b>
			<b>N/A</b>	Shared Landing?	<b>N/A</b>
			<b>N/A</b>	Gutter Ponding?	<b>N/A</b>
			<b>N/A</b>	Gutter Lip Ht (in)	<b>N/A</b>
			<b>N/A</b>	Painted X Walk1?	<b>No</b>
				X Walk 1 Direction	<b>To S</b>
			<b>N/A</b>	X Walk 1 Width (in)	<b>N/A</b>
				X Walk 1 Slope (%)	<b>1.7</b>
				X Walk 1 X Slope (%)	<b>4.5</b>
			<b>N/A</b>	Ramp inside XWalk1?	<b>N/A</b>
			<b>N/A</b>	Road Slope (%)	<b>N/A</b>
			<b>N/A</b>	Road X Slope (%)	<b>N/A</b>
			<b>N/A</b>	Any Obstructions?	<b>N/A</b>
Total Cost:		<b>\$ 1850.00</b>		Obstruction Type	
			<b>N/A</b>		<b>N/A</b>
			<b>Yes</b>	Surface Condition? (G/P)	<b>Good</b>
