# Access Compliance Report

## Public Rights-of-Way

### (Curb Ramps)

Intersection ID: 27070	Main Street: ANDREWS_LINKS_ST	Cross Street: LINKS_DR	Location: SE
ADA ID: 199A6846E574	Ramp Type: PerpDiag	Initial Pass/Fail: Fail	Overall Compliance: No
Codes/Mitigation Info/Possible Solution		Field Measurements/Component Compliance	
Severity Score: 33.75

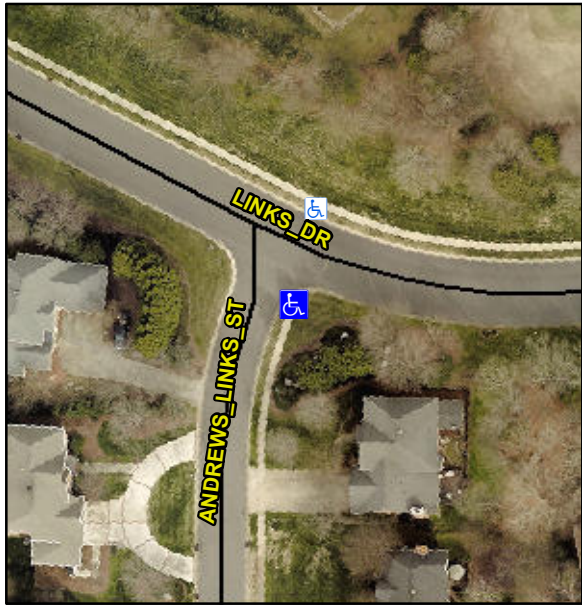
Compliance	Description	Data	Compliance	Description	Data
N/A	Ramp Length (in)	95.0	Yes	Ramp Slope (%)	7.9
No	Ramp Width (in)	47.5	No	Ramp XSlope (%)	14.3
N/A	Flare Type LT	N/A	N/A	Flare Type RT	N/A
N/A	Flare Slope LT (%)	N/A	N/A	Flare Slope RT (%)	N/A
N/A	Flare Traversable LT?	N/A	N/A	Flare Traversable RT?	N/A
N/A	Landing Length (in)	N/A	N/A	DWS Provided?	N/A
N/A	Landing Width (in)	N/A	N/A	DWS Contrast?	N/A
N/A	Landing Slope (%)	N/A	N/A	DWS Length (in)	N/A
N/A	Landing X Slope (%)	N/A	N/A	DWS Full Width?	N/A
N/A	Landing Curb? (Y/N)	N/A	N/A	DWS Offset (in)	N/A
N/A	Shared Landing?	N/A			
N/A	Gutter Ponding?	N/A	N/A	Gutter Slope (%)	N/A
N/A	Gutter Lip Ht (in)	N/A	N/A	Gutter X Slope (%)	N/A
N/A	Painted X Walk1?	No	N/A	Painted X Walk2?	No
	X Walk 1 Direction	To NE		X Walk 2 Direction	To NW
N/A	X Walk 1 Width (in)	N/A	N/A	X Walk 2 Width (in)	N/A
	X Walk 1 Slope (%)	2.3		X Walk 2 Slope (%)	8.3
	X Walk 1 X Slope (%)	11.4		X Walk 2 X Slope (%)	6.4

N/A	Ramp inside XWalk1?	N/A	N/A	Ramp inside XWalk2?	N/A
	Road Slope (%)	11.0	N/A	Clear Space?	N/A
	Road X Slope (%)	10.0	N/A	Clear Space to XWalk (in)	N/A
N/A	Any Obstructions?	N/A	N/A	Storm Grate/Utility Hazard?	N/A
	Obstruction Type			Storm Grate/Utility Type	
		N/A			N/A
			Yes	Surface Condition? (G/P)	Good

Possible Solutions:

Remove & Replace Curb Ramp With Two New Directional Ramps or Equivalent.

R304.5.1, R304.5.3
