# Access Compliance Report

## Public Rights-of-Way

### (Curb Ramps)

Intersection ID: 50538	Main Street: CAYENNE_DR	Cross Street: CILANTRO_WY	Location: SW
ADA ID: 19A93ECA79C1	Ramp Type: PerpDiag	Initial Pass/Fail: Fail	Overall Compliance: No
Severity Score: 10			
Codes/Mitigation Info/Possible Solution		Field Measurements/Component Compliance

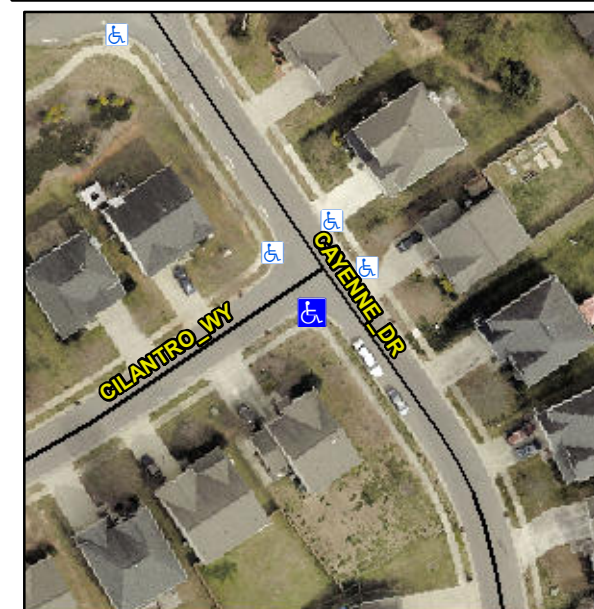
**Not Found, R304.5.1, R304.5.3**

Compliance	Description	Data	Compliance	Description	Data
N/A	Ramp Length (in)	48.0	Yes	Ramp Slope (%)	5.7
No	Ramp Width (in)	45.0	No	Ramp XSlope (%)	4.7
N/A	Flare Type LT	N/A	N/A	Flare Type RT	N/A
N/A	Flare Slope LT (%)	N/A	N/A	Flare Slope RT (%)	N/A
N/A	Flare Traversable LT?	N/A	N/A	Flare Traversable RT?	N/A
N/A	Landing Length (in)	N/A	N/A	DWS Provided?	N/A
N/A	Landing Width (in)	N/A	N/A	DWS Contrast?	N/A
N/A	Landing Slope (%)	N/A	N/A	DWS Length (in)	N/A
N/A	Landing X Slope (%)	N/A	N/A	DWS Full Width?	N/A
N/A	Landing Curb? (Y/N)	N/A	N/A	DWS Offset (in)	N/A
N/A	Shared Landing?	N/A			
N/A	Gutter Ponding?	N/A	N/A	Gutter Slope (%)	N/A
N/A	Gutter Lip Ht (in)	N/A	N/A	Gutter X Slope (%)	N/A
N/A	Painted X Walk1?	No	N/A	Painted X Walk2?	No
	X Walk 1 Direction	To E		X Walk 2 Direction	To N
N/A	X Walk 1 Width (in)	N/A	N/A	X Walk 2 Width (in)	N/A
	X Walk 1 Slope (%)	4.2		X Walk 2 Slope (%)	10.7
	X Walk 1 X Slope (%)	8.8		X Walk 2 X Slope (%)	2.3

N/A	Ramp inside XWalk1?	N/A	N/A	Ramp inside XWalk2?	N/A
	Road Slope (%)	5.2	N/A	Clear Space?	N/A
	Road X Slope (%)	9.9	N/A	Clear Space to XWalk (in)	N/A
N/A	Any Obstructions?	N/A	N/A	Storm Grate/Utility Hazard?	N/A
	Obstruction Type			Storm Grate/Utility Type	
		N/A			N/A
		Yes		Surface Condition? (G/P)	Good

**Remove & Replace Curb Ramp With Two New Directional Ramps or Equivalent.**
