Intersection ID: 13395 Main Street: LOVE\_AV Cross Street: N\_SHARON\_AMITY\_RD Location: NW

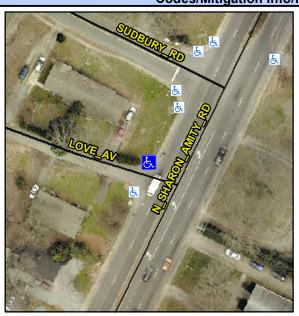
Not Found, R304.5.1, R304.2.2, R304.5.3

Field Measurements/Component Compliance							
Compliance Description		Data	Comp	liance Description	Data		
	N/A	Ramp Length (in)	55.0	No	Ramp Slope (%)	11.9	
	No	Ramp Width (in)	30.0	No	Ramp XSlope (%)	2.4	
	N/A	Flare Type LT	N/A	N/A	Flare Type RT	N/A	
	N/A	Flare Slope LT (%)	N/A	N/A	Flare Slope RT (%)	N/A	
	N/A	Flare Traversable LT?	N/A	N/A	Flare Traversable RT?	N/A	
	N/A	Landing Length (in)	N/A	N/A	DWS Provided?	N/A	
	N/A	Landing Width (in)	N/A	N/A	DWS Contrast?	N/A	
	N/A	Landing Slope (%)	N/A	N/A	DWS Length (in)	N/A	
	N/A	Landing X Slope (%)	N/A	N/A	DWS Full Width?	N/A	
	N/A	Landing Curb? (Y/N)	N/A	N/A	DWS Offset (in)	N/A	
	N/A	Shared Landing?	N/A				
	N/A	Gutter Ponding?	N/A	N/A	Gutter Slope (%)	N/A	
	N/A	Gutter Lip Ht (in)	0.5	N/A	Gutter X Slope (%)	N/A	
	N/A	Painted X Walk1?	No	N/A	Painted X Walk2?	N/A	
		X Walk 1 Direction	To SW		X Walk 2 Direction	N/A	
	N/A	X Walk 1 Width (in)	N/A	N/A	X Walk 2 Width (in)	N/A

X Walk 1 Slope (%)	0.4		X Walk 2 Slope (%)	N/A	
		X Walk 1 X Slope (%)	1.9		X Walk 2 X Slope (%)	N/A	
	N/A	Ramp inside XWalk1?	N/A	N/A	Ramp inside XWalk2?	N/A	
		Road Slope (%)	N/A	N/A	Clear Space?	N/A	
		Road X Slope (%)	N/A	N/A	Clear Space to XWalk (in)	N/A	
	N/A	Any Obstructions?	N/A	N/A	Storm Grate/Utility Hazard?	N/A	
		Obstruction Type			Storm Grate/Utility Type		
			N/A			N/A	
				Yes	Surface Condition? (G/P)	Good

Remove & Replace Entire Ramp.
