Access Compliance Report

Public Rights-of-Way

(Curb Ramps)

Intersection ID: 27530	Main Street: BALLANTYNE_COMMONS_PY	Cross Street: BALLANTYNE_FOREST_DR	Location: SE
ADA ID: 19AC00500E52	Ramp Type: Perp	Initial Pass/Fail: Fail	Overall Compliance: No
Severity Score: 22.5			
Codes/Mitigation Info/Possible Solution		Field Measurements/Component Compliance

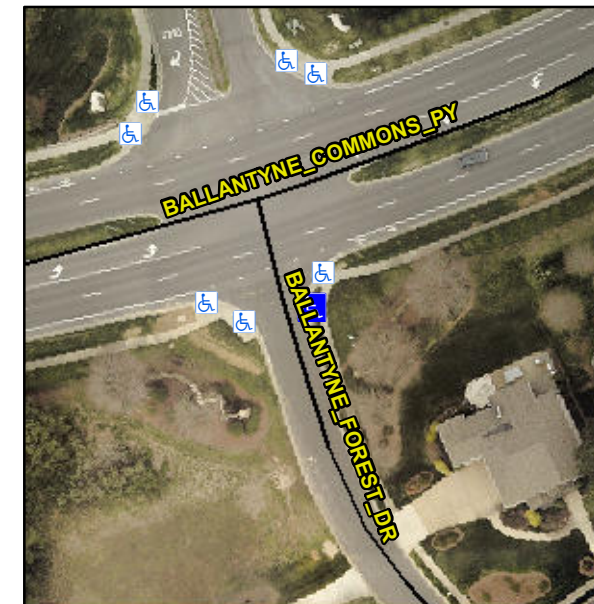
Not Found, R304.5.1, R304.2.2, R304.5.3

Compliance	Description	Data	Compliance	Description	Data
N/A	Ramp Length (in)	50.0	No	Ramp Slope (%)	9.5
No	Ramp Width (in)	47.0	No	Ramp XSlope (%)	3.9
N/A	Flare Type LT	N/A	N/A	Flare Type RT	N/A
N/A	Flare Slope LT (%)	N/A	N/A	Flare Slope RT (%)	N/A
N/A	Flare Traversable LT?	N/A	N/A	Flare Traversable RT?	N/A
N/A	Landing Length (in)	N/A	N/A	DWS Provided?	N/A
N/A	Landing Width (in)	N/A	N/A	DWS Contrast?	N/A
N/A	Landing Slope (%)	N/A	N/A	DWS Length (in)	N/A
N/A	Landing X Slope (%)	N/A	N/A	DWS Full Width?	N/A
N/A	Landing Curb? (Y/N)	N/A	N/A	DWS Offset (in)	N/A
N/A	Shared Landing?	N/A			
N/A	Gutter Ponding?	N/A	N/A	Gutter Slope (%)	N/A
N/A	Gutter Lip Ht (in)	N/A	N/A	Gutter X Slope (%)	N/A
N/A	Painted X Walk1?	No	N/A	Painted X Walk2?	N/A
	X Walk 1 Direction	To W		X Walk 2 Direction	N/A
N/A	X Walk 1 Width (in)	N/A	N/A	X Walk 2 Width (in)	N/A
	X Walk 1 Slope (%)	1.9		X Walk 2 Slope (%)	N/A
	X Walk 1 X Slope (%)	1.4		X Walk 2 X Slope (%)	N/A

N/A	Ramp inside XWalk1?	N/A	N/A	Ramp inside XWalk2?	N/A
	Road Slope (%)	N/A	N/A	Clear Space?	N/A
	Road X Slope (%)	N/A	N/A	Clear Space to XWalk (in)	N/A
N/A	Any Obstructions?	N/A	N/A	Storm Grate/Utility Hazard?	N/A
	Obstruction Type			Storm Grate/Utility Type	
		N/A			N/A
			Yes	Surface Condition? (G/P)	Good

Remove & Replace Entire Ramp.
