Access Compliance Report Public Rights-of-Way (Curb Ramps)

Intersection ID: 14154 Main Street: DILWORTH RD **Cross Street: MT VERNON AV** Location: SW ADA ID: 19D17499F420 Ramp Type: PerpDiag Initial Pass/Fail: Fail **Overall Compliance: No** Severity Score: 13.75

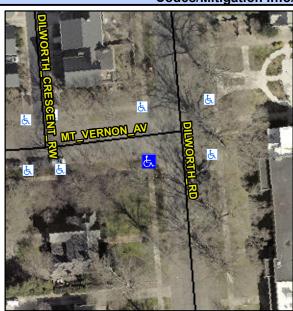
Field Measurements/Component Compliance							
Compliance Description D		Data	Comp	liance Description	Data		
N/A	Ramp Length (in)	89.0	No	Ramp Slope (%)	8.4		
Yes	Ramp Width (in)	48.0	No	Ramp XSlope (%)	2.9		
N/A	Flare Type LT	N/A	N/A	Flare Type RT	N/A		
N/A	Flare Slope LT (%)	N/A	N/A	Flare Slope RT (%)	N/A		
N/A	Flare Traversable LT?	N/A	N/A	Flare Traversable RT?	N/A		
N/A	Landing Length (in)	N/A	N/A	DWS Provided?	N/A		
N/A	Landing Width (in)	N/A	N/A	DWS Contrast?	N/A		
N/A	Landing Slope (%)	N/A	N/A	DWS Length (in)	N/A		
N/A	Landing X Slope (%)	N/A	N/A	DWS Full Width?	N/A		
N/A	Landing Curb? (Y/N)	N/A	N/A	DWS Offset (in)	N/A		
N/A	Shared Landing?	N/A					
N/A	Gutter Ponding?	N/A	N/A	Gutter Slope (%)	N/A		
N/A	Gutter Lip Ht (in)	1.0	N/A	Gutter X Slope (%)	N/A		
N/A	Painted X Walk1?	No	N/A	Painted X Walk2?	No		
	X Walk 1 Direction	To E		X Walk 2 Direction	To N		
N/A	X Walk 1 Width (in)	N/A	N/A	X Walk 2 Width (in)	N/A

X Walk 1 Slope (%)	1.0		X Walk 2 Slope (%)	0.0		
	X Walk 1 X Slope (%)	0.5		X Walk 2 X Slope (%)	0.9		
N/A	Ramp inside XWalk1?	N/A	N/A	Ramp inside XWalk2?	N/A		
	Road Slope (%)	0.4	N/A	Clear Space?	N/A		
	Road X Slope (%)	1.2	N/A	Clear Space to XWalk (in)	N/A		
N/A	Any Obstructions?	N/A	N/A	Storm Grate/Utility Hazard?	N/A		
	Obstruction Type			Storm Grate/Utility Type			
		N/A			N/A		
			Yes	Surface Condition? (G/P)	Good

DILWORTH RD None MT VERNON AV StopSign Remove & Replace Curb Ramp With Two New Directional Ramps or Equivalent.

R304.2.2, R304.5.3

3200.00
