## Access Compliance Report Public Rights-of-Way (Curb Ramps)

Intersection ID: 29294 Main Street: LOOKING\_GLASS\_LN Cross Street: FAR\_WEST\_DR Location: W

ADA ID: 19D6602A0F59 Ramp Type: PerpDiag Initial Pass/Fail: Fail Overall Compliance: No Severity Score: 8.75

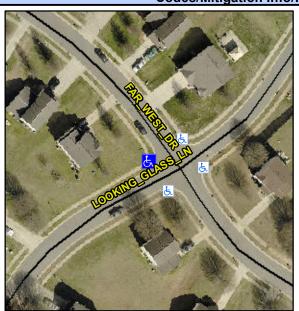
Not Found, R304.5.1

| Compliance Description | | Data | | liance Description | Data |
|---|---|---|---|---|---|
| No | Ramp Width (in) | 46.0 | Yes | Ramp XSlope (%) | 0.4 |

LOOKING GLASS LN StopSign FAR WEST DR None Possible Solutions:

Remove & Replace Curb Ramp With
Two New Directional Ramps or
Equivalent.

Total Cost: \$ 3200.00
