Access Compliance Report

Public Rights-of-Way

(Curb Ramps)

Intersection ID: 17241	Main Street: S_CANTERBURY_RD	Cross Street: S_WENDOVER_RD	Location: SE
ADA ID: 19D74C5A9E3E	Ramp Type: Directional1	Initial Pass/Fail: Fail	Overall Compliance: No
Severity Score: 1.25			
Codes/Mitigation Info/Possible Solution		Field Measurements/Component Compliance

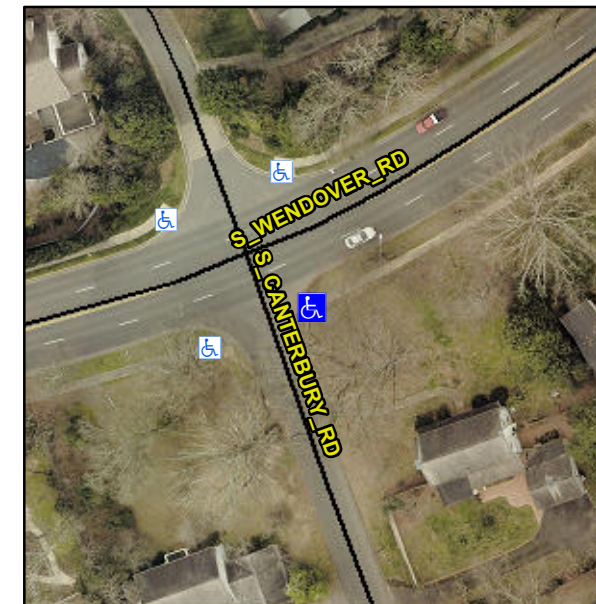
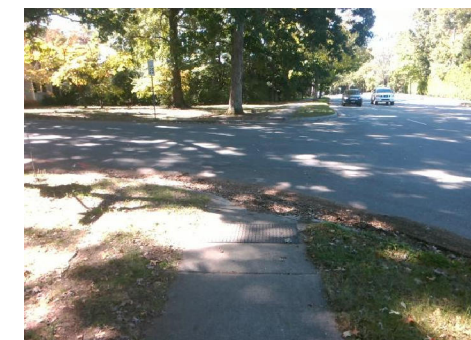
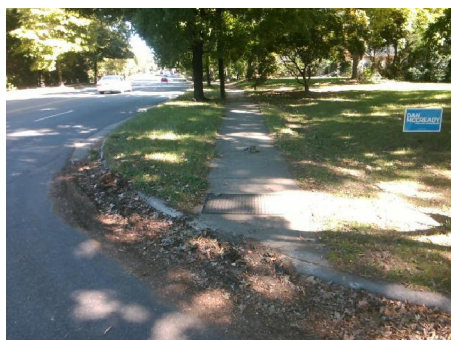
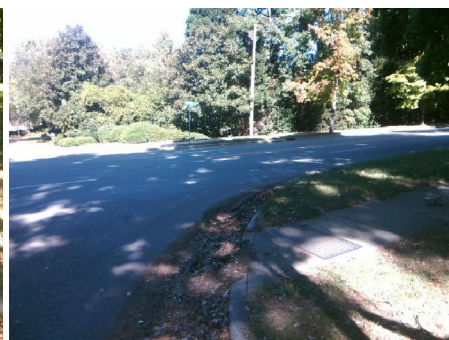
Compliance	Description	Data	Compliance	Description	Data
N/A	Ramp Length (in)	57.0	N/A	Grade Break?	N/A
Yes	Ramp Width (in)	57.0	N/A	Grade Break Slope (%)	0.0
Yes	Ramp Slope (%)	6.6	N/A	Grade Break XSlope (%)	0.0
No	Ramp XSlope (%)	2.6			
N/A	Flare Type LT	N/A	N/A	Flare Type RT	N/A
N/A	Flare Slope LT (%)	N/A	N/A	Flare Slope RT (%)	0.0
N/A	Flare Traversable LT?	N/A	N/A	Flare Traversable RT?	N/A
N/A	Landing Length (in)	0.0	N/A	DWS Provided?	N/A
N/A	Landing Width (in)	0.0	N/A	DWS Contrast?	N/A
N/A	Landing Slope (%)	0.0	N/A	DWS Length (in)	N/A
N/A	Landing X Slope (%)	0.0	N/A	DWS Full Width?	N/A
N/A	Landing Curb? (Y/N)	N/A	N/A	DWS Offset LT (in)	N/A
N/A	Shared Landing?	N/A	N/A	DWS Offset RT (in)	N/A
N/A	Gutter Ponding?	0.0	N/A	Gutter Slope (%)	N/A
N/A	Gutter Lip Ht (in)	0.0	N/A	Gutter X Slope (%)	N/A
N/A	Painted X Walk1?	No		Road Slope (%)	1.8
	X Walk 1 Direction	To SW		Road X Slope (%)	0.7
	X Walk 1 Width (in)	N/A		Clear Space?	N/A

X Walk 1 Slope (%)	1.8	N/A	Clear Space to XWalk (in)	N/A
	X Walk 1 X Slope (%)	0.7	N/A	Storm Grate/Utility Hazard?	N/A
N/A	Ramp inside XWalk1?	N/A		Storm Grate/Utility Type	
N/A	Any Obstructions?	N/A			N/A
	Obstruction Type		Yes	Surface Condition? (G/P)	Good
			N/A	Curb Slope (%)	12.6

Remove & Replace Entire Ramp.
