## Access Compliance Report Public Rights-of-Way (Curb Ramps)

Intersection ID: 8595 Main Street: GENERAL\_COMMERCE\_DR Cross Street: ORR\_RD Location: W

ADA ID: 19DA00CF74DD Ramp Type: PerpDiag Initial Pass/Fail: Fail Overall Compliance: No Severity Score: 22.5

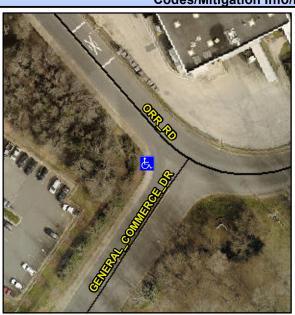
Not Found, R304.5.1, R304.2.2, R304.5.3

No N/A Ramp Length (in) 54.5 Ramp Slope (%) No No Ramp Width (in) 40.0 Ramp XSlope (%) N/A N/A Flare Type LT N/A Flare Type RT N/A N/A N/A Flare Slope RT (%) Flare Slope LT (%) N/A Flare Traversable LT? N/A N/A Flare Traversable RT? N/A N/A N/A **DWS Provided?** Landing Length (in) N/A Landing Width (in) N/A N/A **DWS Contrast?** N/A N/A N/A Landing Slope (%) DWS Length (in) N/A Landing X Slope (%) N/A N/A DWS Full Width? N/A Landing Curb? (Y/N) N/A N/A DWS Offset (in) N/A N/A Shared Landing? N/A Gutter Ponding? N/A N/A Gutter Slope (%) N/A Gutter Lip Ht (in) N/A N/A Gutter X Slope (%) N/A Painted X Walk1? No N/A Painted X Walk2? X Walk 1 Direction To SE X Walk 2 Direction N/A N/A X Walk 1 Width (in) X Walk 2 Width (in) X Walk 1 Slope (%) N/A X Walk 2 Slope (%) X Walk 1 X Slope (%) N/A X Walk 2 X Slope (%) N/A N/A N/A Ramp inside XWalk2? Ramp inside XWalk1? Road Slope (%) 0.6 N/A Clear Space? N/A Road X Slope (%) 2.2 Clear Space to XWalk (in) N/A N/A N/A Any Obstructions? Storm Grate/Utility Hazard?

Remove & Replace Curb Ramp With Two New Directional Ramps or Equivalent.
