Access Compliance Report

Public Rights-of-Way (Curb Ramps)

Intersection ID: 10350	Main Street: BANCROFT_ST	Cross Street: KESWICK_AV	Location:	N
ADA ID: 19EB50FC9B4A	Ramp Type: PerpDiag	Initial Pass/Fail: Fail	Overall Compliance: No	Severity Score: 25

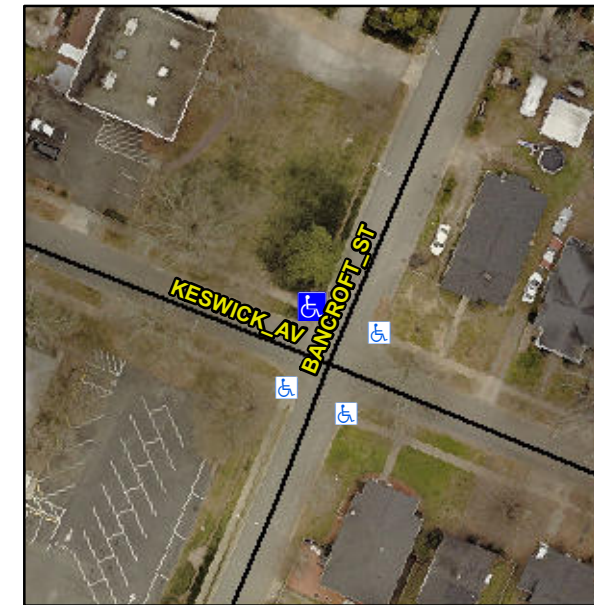
Compliance	Description	Data	Compliance	Description	Data
N/A	Ramp Length (in)	66.0	No	Ramp Slope (%)	13.0
Yes	Ramp Width (in)	57.5	Yes	Ramp XSlope (%)	0.8
N/A	Flare Type LT	N/A	N/A	Flare Type RT	N/A
N/A	Flare Slope LT (%)	N/A	N/A	Flare Slope RT (%)	N/A
N/A	Flare Traversable LT?	N/A	N/A	Flare Traversable RT?	N/A
N/A	Landing Length (in)	N/A	N/A	DWS Provided?	N/A
N/A	Landing Width (in)	N/A	N/A	DWS Contrast?	N/A
N/A	Landing Slope (%)	N/A	N/A	DWS Length (in)	N/A
N/A	Landing X Slope (%)	N/A	N/A	DWS Full Width?	N/A
N/A	Landing Curb? (Y/N)	N/A	N/A	DWS Offset (in)	N/A
N/A	Shared Landing?	N/A			
N/A	Gutter Ponding?	Yes	N/A	Gutter Slope (%)	N/A
N/A	Gutter Lip Ht (in)	N/A	N/A	Gutter X Slope (%)	N/A
N/A	Painted X Walk1?	No	N/A	Painted X Walk2?	No
	X Walk 1 Direction	To SW		X Walk 2 Direction	To SE
N/A	X Walk 1 Width (in)	N/A	N/A	X Walk 2 Width (in)	N/A
	X Walk 1 Slope (%)	2.3		X Walk 2 Slope (%)	1.0
	X Walk 1 X Slope (%)	1.3		X Walk 2 X Slope (%)	0.8

N/A	Ramp inside XWalk1?	N/A	N/A	Ramp inside XWalk2?	N/A
	Road Slope (%)	1.7	N/A	Clear Space?	N/A
	Road X Slope (%)	1.3	N/A	Clear Space to XWalk (in)	N/A
N/A	Any Obstructions?	N/A	N/A	Storm Grate/Utility Hazard?	N/A
	Obstruction Type			Storm Grate/Utility Type	
		N/A			N/A
		Yes		Surface Condition? (G/P)	Good

Remove & Replace Curb Ramp With Two New Directional Ramps or Equivalent.
