# Access Compliance Report

## Public Rights-of-Way

| Intersection ID: 27178 | Main Street: MCKEE_RD | Cross Street: SIKES_PL | Location: SE |
| ADA ID: 19F6C85F167C | Ramp Type: BlendTrans1 | Initial Pass/Fail: Fail | Overall Compliance: No |

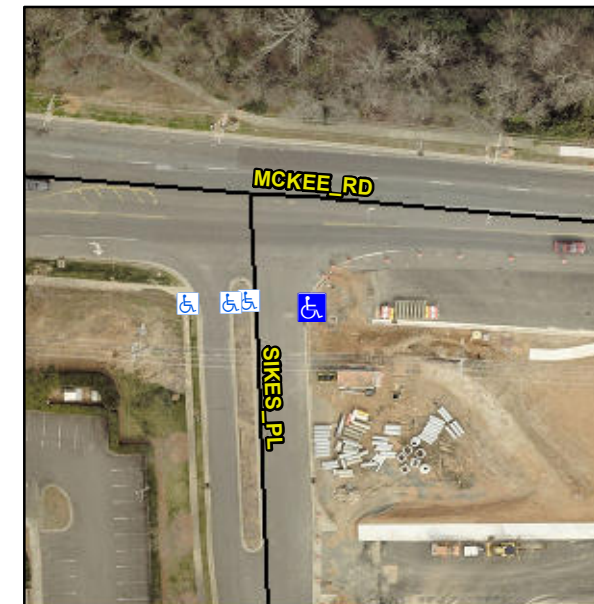
#### Field Measurements/Component Compliance

**Not Found, R304.5.3**

| Compliance | Description | Data | Compliance | Description | Data |
|---|---|---|---|---|---|
| Yes | Ramp Width (in) | 58.0 | No | BlendTrans XSlope (%) | 2.3 |
| | | | No | Curb Slope (%) | 16.0 |

**Remove & Replace Curb Ramp With Two New Directional Ramps or Equivalent.**

Total Cost: \$ 3200.00

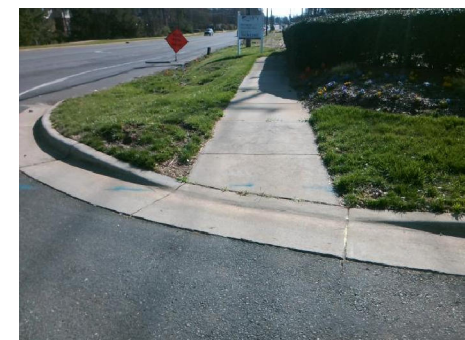
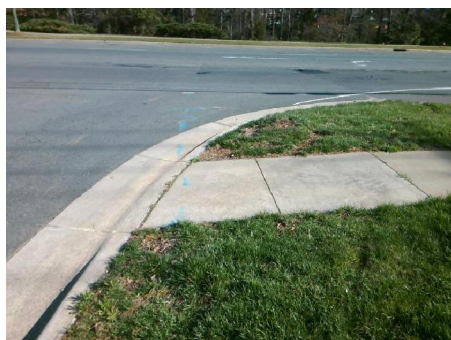
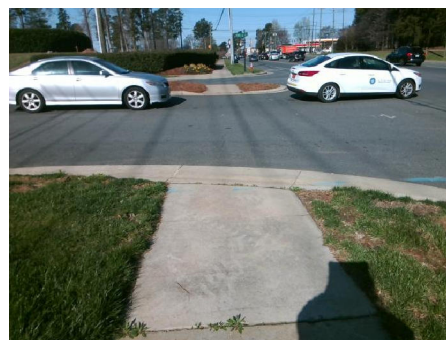
| | | Severity Score: 1.25 | |
