Access Compliance Report

Public Rights-of-Way (Curb Ramps)

Intersection ID: 15450	Main Street: ALBEMARLE_RD	Cross Street: PIERSON_DR	Location: NW
ADA ID: 19FF28085775	Ramp Type: Perp	Initial Pass/Fail: Fail	Overall Compliance: No
Codes/Mitigation Info/Possible Solution		Field Measurements/Component Compliance	
Severity Score: 22.5

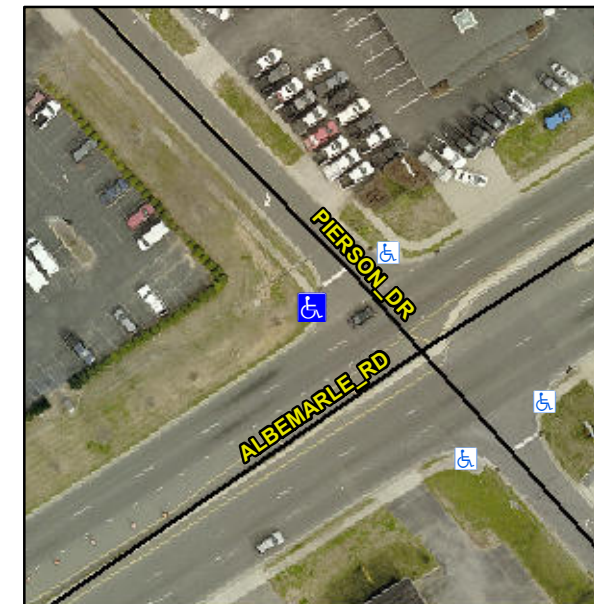
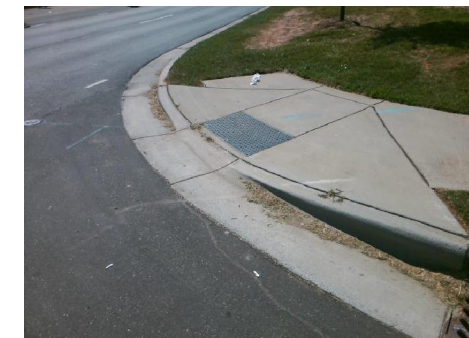
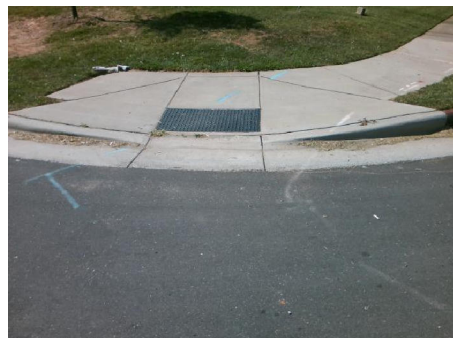
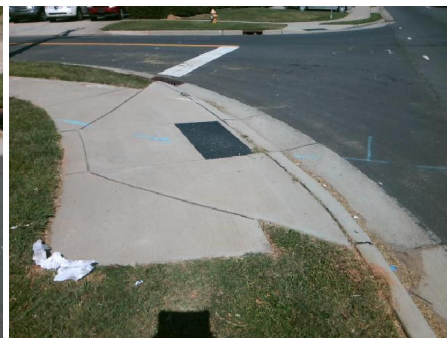
Not Found, R304.5.1, R304.2.2, R304.5.3

Compliance	Description	Data	Compliance	Description	Data
N/A	Ramp Length (in)	75.0	No	Ramp Slope (%)	8.8
No	Ramp Width (in)	45.0	No	Ramp XSlope (%)	4.6
N/A	Flare Type LT	N/A	N/A	Flare Type RT	N/A
N/A	Flare Slope LT (%)	N/A	N/A	Flare Slope RT (%)	N/A
N/A	Flare Traversable LT?	N/A	N/A	Flare Traversable RT?	N/A
N/A	Landing Length (in)	N/A	N/A	DWS Provided?	N/A
N/A	Landing Width (in)	N/A	N/A	DWS Contrast?	N/A
N/A	Landing Slope (%)	N/A	N/A	DWS Length (in)	N/A
N/A	Landing X Slope (%)	N/A	N/A	DWS Full Width?	N/A
N/A	Landing Curb? (Y/N)	N/A	N/A	DWS Offset (in)	N/A
N/A	Shared Landing?	N/A			
N/A	Gutter Ponding?	N/A	N/A	Gutter Slope (%)	N/A
N/A	Gutter Lip Ht (in)	N/A	N/A	Gutter X Slope (%)	N/A
N/A	Painted X Walk1?	No	N/A	Painted X Walk2?	N/A
	X Walk 1 Direction	To NE		X Walk 2 Direction	N/A
N/A	X Walk 1 Width (in)	N/A	N/A	X Walk 2 Width (in)	N/A
	X Walk 1 Slope (%)	3.0		X Walk 2 Slope (%)	N/A
	X Walk 1 X Slope (%)	2.5		X Walk 2 X Slope (%)	N/A

N/A	Ramp inside XWalk1?	N/A	N/A	Ramp inside XWalk2?	N/A
	Road Slope (%)	N/A	N/A	Clear Space?	N/A
	Road X Slope (%)	N/A	N/A	Clear Space to XWalk (in)	N/A
N/A	Any Obstructions?	N/A	N/A	Storm Grate/Utility Hazard?	N/A
	Obstruction Type			Storm Grate/Utility Type	
		N/A			N/A
			Yes	Surface Condition? (G/P)	Good

Remove & Replace Entire Ramp.
