Access Compliance Report

Public Rights-of-Way

(Curb Ramps)

Intersection ID: 15827	Main Street: CLANTON_RD	Cross Street: PELTON_ST	Location: NE
ADA ID: 1A09096C127D	Ramp Type: Directional1	Initial Pass/Fail: Fail	Overall Compliance: No
		Severity Score: 12.5

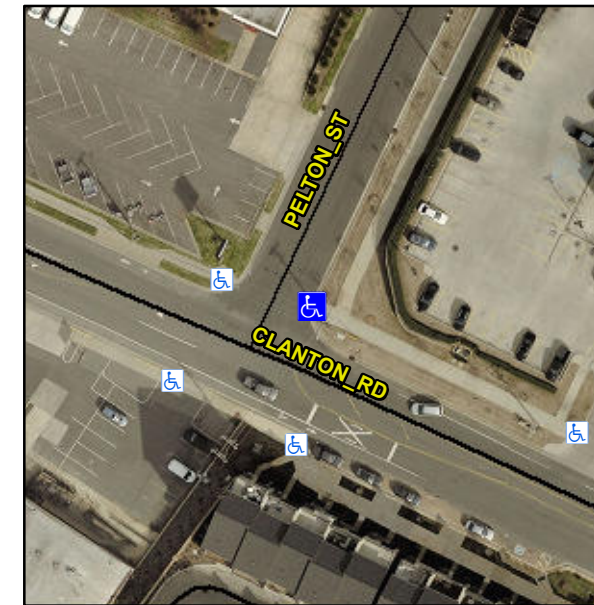
Compliance	Description	Data	Compliance	Description	Data
N/A	Ramp Length (in)	122.0	N/A	Grade Break?	N/A
Yes	Ramp Width (in)	93.0	N/A	Grade Break Slope (%)	0.0
No	Ramp Slope (%)	8.5	N/A	Grade Break XSlope (%)	0.0
Yes	Ramp XSlope (%)	1.4			
N/A	Flare Type LT	N/A	N/A	Flare Type RT	N/A
N/A	Flare Slope LT (%)	N/A	N/A	Flare Slope RT (%)	0.0
N/A	Flare Traversable LT?	N/A	N/A	Flare Traversable RT?	N/A
N/A	Landing Length (in)	0.0	N/A	DWS Provided?	N/A
N/A	Landing Width (in)	0.0	N/A	DWS Contrast?	N/A
N/A	Landing Slope (%)	0.0	N/A	DWS Length (in)	N/A
N/A	Landing X Slope (%)	0.0	N/A	DWS Full Width?	N/A
N/A	Landing Curb? (Y/N)	N/A	N/A	DWS Offset LT (in)	N/A
N/A	Shared Landing?	N/A	N/A	DWS Offset RT (in)	N/A
N/A	Gutter Ponding?	0.0	N/A	Gutter Slope (%)	N/A
N/A	Gutter Lip Ht (in)	0.0	N/A	Gutter X Slope (%)	N/A
N/A	Painted X Walk1?	No		Road Slope (%)	4.7
	X Walk 1 Direction	To W		Road X Slope (%)	5.1
	X Walk 1 Width (in)	N/A		Clear Space?	N/A

X Walk 1 Slope (%)	4.7	N/A	Clear Space to XWalk (in)	N/A
	X Walk 1 X Slope (%)	5.1	N/A	Storm Grate/Utility Hazard?	N/A
N/A	Ramp inside XWalk1?	N/A		Storm Grate/Utility Type	
N/A	Any Obstructions?	N/A			N/A
	Obstruction Type		Yes	Surface Condition? (G/P)	Good
			N/A	Curb Slope (%)	1.3

Possible Solutions:

Remove & Replace Entire Ramp.

PROW/ADA:

R304.2.2
