Access Compliance Report

Public Rights-of-Way

(Curb Ramps)

Intersection ID: 20507	Main Street: SARDIS_RD	Cross Street: BOYCE_RD	Location: SE
ADA ID: 1A14ABA6ED3F	Ramp Type: PerpDiag	Initial Pass/Fail: Fail	Overall Compliance: No
		Severity Score: 10

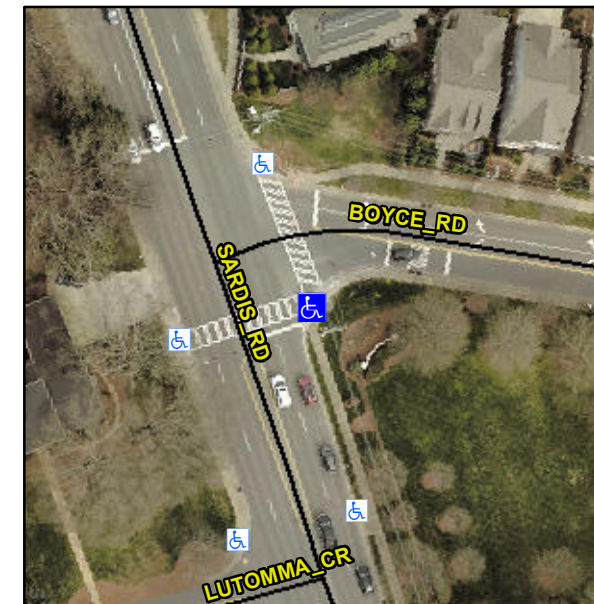
Not Found, R304.5.1, R304.5.3

Compliance	Description	Data	Compliance	Description	Data
N/A	Ramp Length (in)	59.0	Yes	Ramp Slope (%)	6.1
No	Ramp Width (in)	42.0	No	Ramp XSlope (%)	2.3
N/A	Flare Type LT	N/A	N/A	Flare Type RT	N/A
N/A	Flare Slope LT (%)	N/A	N/A	Flare Slope RT (%)	N/A
N/A	Flare Traversable LT?	N/A	N/A	Flare Traversable RT?	N/A
N/A	Landing Length (in)	N/A	N/A	DWS Provided?	N/A
N/A	Landing Width (in)	N/A	N/A	DWS Contrast?	N/A
N/A	Landing Slope (%)	N/A	N/A	DWS Length (in)	N/A
N/A	Landing X Slope (%)	N/A	N/A	DWS Full Width?	N/A
N/A	Landing Curb? (Y/N)	N/A	N/A	DWS Offset (in)	N/A
N/A	Shared Landing?	N/A			
N/A	Gutter Ponding?	N/A	N/A	Gutter Slope (%)	N/A
N/A	Gutter Lip Ht (in)	N/A	N/A	Gutter X Slope (%)	N/A
N/A	Painted X Walk1?	Yes	N/A	Painted X Walk2?	Yes
	X Walk 1 Direction	To N		X Walk 2 Direction	To W
N/A	X Walk 1 Width (in)	110.0	N/A	X Walk 2 Width (in)	108.0
	X Walk 1 Slope (%)	3.8		X Walk 2 Slope (%)	0.8
	X Walk 1 X Slope (%)	0.9		X Walk 2 X Slope (%)	3.3

N/A	Ramp inside XWalk1?	Yes	N/A	Ramp inside XWalk2?	Yes
	Road Slope (%)	1.1	N/A	Clear Space?	N/A
	Road X Slope (%)	3.4	N/A	Clear Space to XWalk (in)	N/A
N/A	Any Obstructions?	N/A	N/A	Storm Grate/Utility Hazard?	N/A
	Obstruction Type			Storm Grate/Utility Type	
		N/A			N/A
		Yes		Surface Condition? (G/P)	Good

Remove & Replace Curb Ramp With Two New Directional Ramps or Equivalent.
