# Access Compliance Report

## Public Rights-of-Way

### (Curb Ramps)

Intersection ID: 48058	Main Street: FERRELL_AV	Cross Street: KEENER_RIDGE_RD	Location: NE
ADA ID: 1A15DB903136	Ramp Type: Perp	Initial Pass/Fail: Fail	Overall Compliance: No
		Severity Score: 8.75

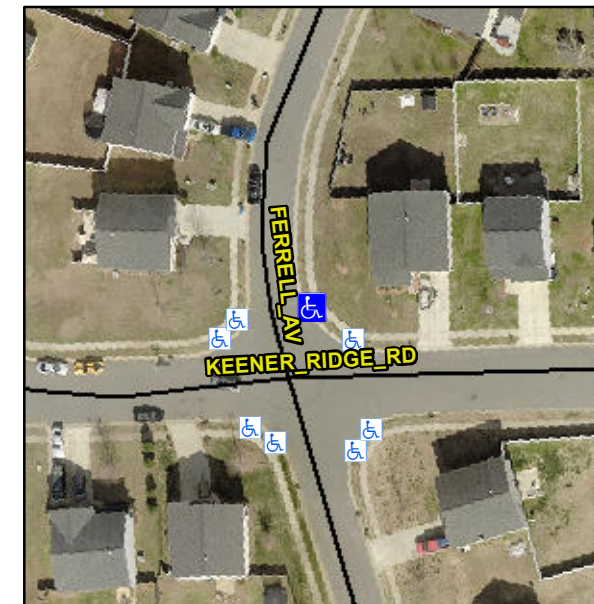
**Not Found, R304.5.1**

Compliance	Description	Data	Compliance	Description	Data
N/A	Ramp Length (in)	47.5	Yes	Ramp Slope (%)	5.9
No	Ramp Width (in)	47.0	Yes	Ramp XSlope (%)	1.4
N/A	Flare Type LT	N/A	N/A	Flare Type RT	N/A
N/A	Flare Slope LT (%)	N/A	N/A	Flare Slope RT (%)	N/A
N/A	Flare Traversable LT?	N/A	N/A	Flare Traversable RT?	N/A
N/A	Landing Length (in)	N/A	N/A	DWS Provided?	N/A
N/A	Landing Width (in)	N/A	N/A	DWS Contrast?	N/A
N/A	Landing Slope (%)	N/A	N/A	DWS Length (in)	N/A
N/A	Landing X Slope (%)	N/A	N/A	DWS Full Width?	N/A
N/A	Landing Curb? (Y/N)	N/A	N/A	DWS Offset (in)	N/A
N/A	Shared Landing?	N/A			
N/A	Gutter Ponding?	N/A	N/A	Gutter Slope (%)	N/A
N/A	Gutter Lip Ht (in)	N/A	N/A	Gutter X Slope (%)	N/A
N/A	Painted X Walk1?	No	N/A	Painted X Walk2?	N/A
	X Walk 1 Direction	To W		X Walk 2 Direction	N/A
N/A	X Walk 1 Width (in)	N/A	N/A	X Walk 2 Width (in)	N/A
	X Walk 1 Slope (%)	6.6		X Walk 2 Slope (%)	N/A
	X Walk 1 X Slope (%)	0.4		X Walk 2 X Slope (%)	N/A

N/A	Ramp inside XWalk1?	N/A	N/A	Ramp inside XWalk2?	N/A
	Road Slope (%)	N/A	N/A	Clear Space?	N/A
	Road X Slope (%)	N/A	N/A	Clear Space to XWalk (in)	N/A
N/A	Any Obstructions?	N/A	N/A	Storm Grate/Utility Hazard?	N/A
	Obstruction Type			Storm Grate/Utility Type	
		N/A			N/A
			Yes	Surface Condition? (G/P)	Good

**Remove & Replace Entire Ramp.**

Total Cost: \$ 1850.00
