# Access Compliance Report

## Public Rights-of-Way

### (Curb Ramps)

Intersection ID: 20954	Main Street: SHARON_VIEW_RD	Cross Street: SOUTH_HILL_VIEW_DR	Location: SW
ADA ID: 1A213442FFC8	Ramp Type: Para	Initial Pass/Fail: Fail	Overall Compliance: No
Codes/Mitigation Info/Possible Solution		Field Measurements/Component Compliance	
Severity Score: 13.75

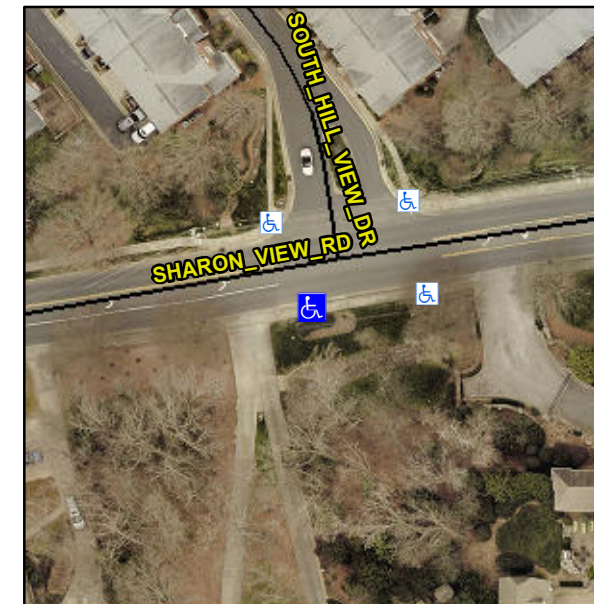
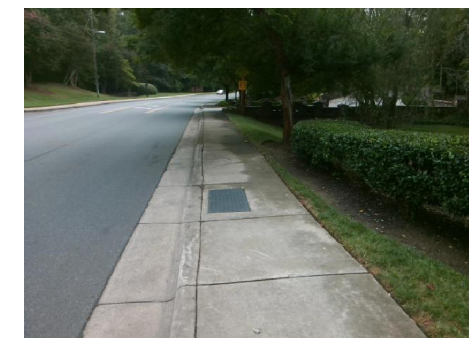
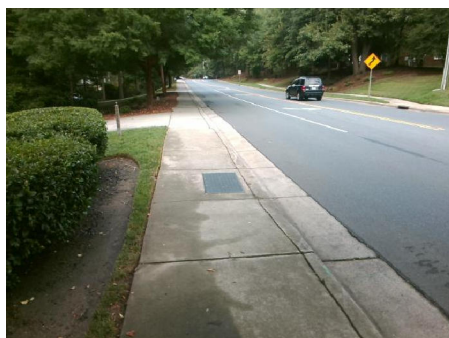
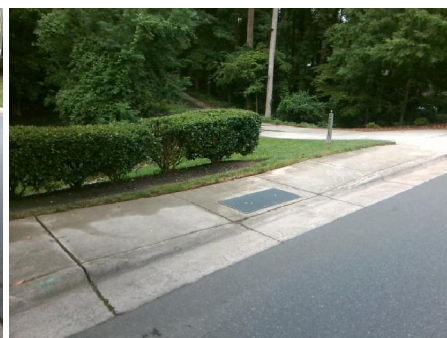
**LT RP < 5%**

**R304.5.3, R304.3.2**

Compliance	Description	Data	Compliance	Description	Data
N/A	Ramp Length LT (in)	72.0	N/A	Ramp Length RT (in)	69.0
Yes	Ramp Width LT (in)	60.0	Yes	Ramp Width RT (in)	60.0
Yes	Ramp Slope LT (%)	2.8	No	Ramp Slope RT (%)	10.3
No	Ramp XSlope LT (%)	3.1	No	Ramp XSlope RT (%)	3.7
N/A	Landing Length (in)	N/A	N/A	DWS Provided?	N/A
N/A	Landing Width (in)	N/A	N/A	DWS Contrast?	N/A
N/A	Landing Slope (%)	N/A	N/A	DWS Length (in)	N/A
N/A	Landing X Slope (%)	N/A	N/A	DWS Full Width?	N/A
N/A	Landing Curb? (Y/N)	N/A	N/A	DWS Offset (in)	N/A
N/A	Shared Landing?	N/A			
N/A	Gutter Ponding?	N/A	N/A	Gutter Slope (%)	N/A
N/A	Gutter Lip Ht (in)	N/A	N/A	Gutter X Slope (%)	N/A
N/A	Painted X Walk1?	No	N/A	Painted X Walk2?	N/A
	X Walk 1 Direction	To NW		X Walk 2 Direction	N/A
N/A	X Walk 1 Width (in)	N/A	N/A	X Walk 2 Width (in)	N/A
	X Walk 1 Slope (%)	3.4		X Walk 2 Slope (%)	N/A
	X Walk 1 X Slope (%)	3.5		X Walk 2 X Slope (%)	N/A
N/A	Ramp inside XWalk1?	N/A	N/A	Ramp inside XWalk2?	N/A

Road Slope (%)	N/A	N/A	Clear Space?	N/A
	Road X Slope (%)	N/A	N/A	Clear Space to XWalk (in)	N/A
N/A	Any Obstructions?	N/A	N/A	Storm Grate/Utility Hazard?	N/A
	Obstruction Type			Storm Grate/Utility Type	
		N/A			N/A
			Yes	Surface Condition? (G/P)	Good
			N/A	Curb Slope (%)	1.1

**Remove & Replace Entire Ramp.**
