Access Compliance Report Public Rights-of-Way (Curb Ramps)

Intersection ID: 8616	Main Street: BEATTIES_FORD_RD			street:	ST_MARK_ST	Location:	E		
ADA ID: 1A2217BE4856	Ramp Type: Perp			Initial Pass/Fail: Fail Overall Compliance: No				o Severity Score:	12.5
Codes/Mitigation Info/Possible Solution			Field Measurements/Component Compliance						
Possible Solutions:				Compliance Description Data Cor			Comp	ompliance Description Data	
		Remove & Replace Entire Ramp		N/A	Ramp Length (in)	83.5	No	Ramp Slope (%)	8.8
the state of the s	- 100			Yes	Ramp Width (in)	48.0	Yes	Ramp XSlope (%)	0.2
HILDEBRAND ST	1-11			N/A	Flare Type LT	N/A	N/A	Flare Type RT	N/A
E T	Constanting of the local division of the			N/A	Flare Slope LT (%)	N/A	N/A	Flare Slope RT (%)	N/A
				N/A	Flare Traversable LT?	N/A	N/A	Flare Traversable RT?	N/A
				N/A	Landing Length (in)	N/A	N/A	DWS Provided?	N/A
	A state of the sta	Surveyor Notes:		N/A	Landing Width (in)	N/A	N/A	DWS Contrast?	N/A
	9 4 1	N/A		N/A	Landing Slope (%)	N/A	N/A	DWS Length (in)	N/A

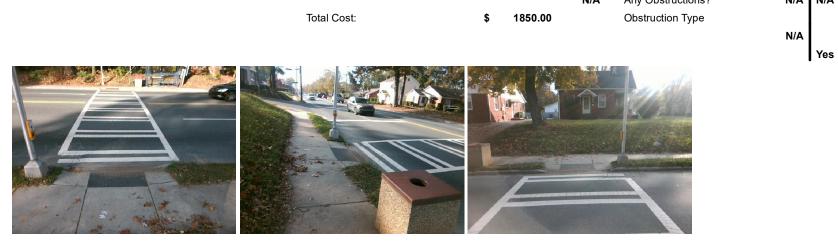
N/A	Landing X Slope (%)	N/A	N/A	DWS Full Width?	N/A
				N/A	Landing Curb? (Y/N)	N/A	N/A	DWS Offset (in)	N/A
	1 Many 50			N/A	Shared Landing?	N/A			
		PROW/ADA:		N/A	Gutter Ponding?	N/A	N/A	Gutter Slope (%)	N/A
A A A A A A A A A A A A A A A A A A A		R304.2.2		N/A	Gutter Lip Ht (in)	N/A	N/A	Gutter X Slope (%)	N/A
	Entertin			N/A	Painted X Walk1?	Yes	N/A	Painted X Walk2?	N/A
	man m				X Walk 1 Direction	To W		X Walk 2 Direction	N/A
	AP AND			N/A	X Walk 1 Width (in)	112.5	N/A	X Walk 2 Width (in)	N/A
Street 1 Name B	EATTIES FORD RD				X Walk 1 Slope (%)	4.6		X Walk 2 Slope (%)	N/A
Stop Condition-Street 2	Signal				X Walk 1 X Slope (%)	0.3		X Walk 2 X Slope (%)	N/A
Street 2 Name	N/A			N/A	Ramp inside XWalk1?	Yes	N/A	Ramp inside XWalk2?	N/A
Stop Condition-Street 1	N/A				Road Slope (%)	N/A	N/A	Clear Space?	N/A
					Road X Slope (%)	N/A	N/A	Clear Space to XWalk (in)	N/A
				N/A	Any Obstructions?	N/A	N/A	Storm Grate/Utility Hazard?	N/A

s Surface Condition? (G/P)

Good

Total Cost: \$	850.00		Obstruction Type			Storm Grate/Utility Type	
						N/A			N/A
