## Access Compliance Report Public Rights-of-Way (Curb Ramps)

Intersection ID: 8828 Main Street: TODDVILLE\_RD Cross Street: URBANA\_DR Location: S

ADA ID: 1A2222D363B8 Ramp Type: Perp Initial Pass/Fail: Fail Overall Compliance: No Severity Score: 8.75

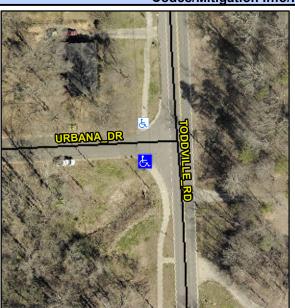
No
N/A
N/A
N/A
Surveyor Notes:
N/A
N/A
N/A
PROW/ADA:
Not Found, R304.5.1

Field Measurements/Component Compliance							
	Compliance Description		Data	Comp	liance Description	Data	
	N/A	Ramp Length (in)	78.0	Yes	Ramp Slope (%)	5.2	
	No	Ramp Width (in)	47.0	Yes	Ramp XSlope (%)	1.7	
	N/A	Flare Type LT	N/A	N/A	Flare Type RT	N/A	
	N/A	Flare Slope LT (%)	N/A	N/A	Flare Slope RT (%)	N/A	
	N/A	Flare Traversable LT?	N/A	N/A	Flare Traversable RT?	N/A	
	N/A	Landing Length (in)	N/A	N/A	DWS Provided?	N/A	
	N/A	Landing Width (in)	N/A	N/A	DWS Contrast?	N/A	
	N/A	Landing Slope (%)	N/A	N/A	DWS Length (in)	N/A	
	N/A	Landing X Slope (%)	N/A	N/A	DWS Full Width?	N/A	
	N/A	Landing Curb? (Y/N)	N/A	N/A	DWS Offset (in)	N/A	
	N/A	Shared Landing?	N/A				
	N/A	Gutter Ponding?	N/A	N/A	Gutter Slope (%)	N/A	
	N/A	Gutter Lip Ht (in)	N/A	N/A	Gutter X Slope (%)	N/A	
	N/A	Painted X Walk1?	No	N/A	Painted X Walk2?	N/A	
		X Walk 1 Direction	To N		X Walk 2 Direction	N/A	
	N/A	X Walk 1 Width (in)	N/A	N/A	X Walk 2 Width (in)	N/A

X Walk 1 Slope (%)	6.2		X Walk 2 Slope (%)	N/A	
		X Walk 1 X Slope (%)	1.1		X Walk 2 X Slope (%)	N/A	
	N/A	Ramp inside XWalk1?	N/A	N/A	Ramp inside XWalk2?	N/A	
		Road Slope (%)	N/A	N/A	Clear Space?	N/A	
		Road X Slope (%)	N/A	N/A	Clear Space to XWalk (in)	N/A	
	N/A	Any Obstructions?	N/A	N/A	Storm Grate/Utility Hazard?	N/A	
		Obstruction Type			Storm Grate/Utility Type		
			N/A			N/A	
				Yes	Surface Condition? (G/P)	Good

Possible Solutions:

Remove & Replace Entire Ramp.
