Access Compliance Report Public Rights-of-Way (Curb Ramps)

Intersection ID: 52172 Main Street: BEARLING_WY Cross Street: AVERY_MEADOWS_DR Location: SE

ADA ID: 1A2A74C397C9 Ramp Type: Perp Initial Pass/Fail: Fail Overall Compliance: No Severity Score: 22.5

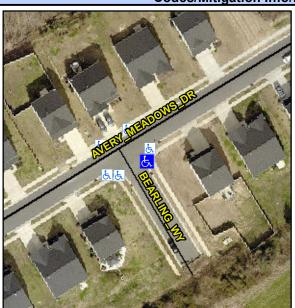
Comp	liance Description	Data	Comp	liance Description	Data
N/A	Ramp Length (in)	49.0	No	Ramp Slope (%)	8.5
No	Ramp Width (in)	46.0	No	Ramp XSlope (%)	2.8
N/A	Flare Type LT	N/A	N/A	Flare Type RT	N/A
N/A	Flare Slope LT (%)	N/A	N/A	Flare Slope RT (%)	N/A
N/A	Flare Traversable LT?	N/A	N/A	Flare Traversable RT?	N/A
N/A	Landing Length (in)	N/A	N/A	DWS Provided?	N/A
N/A	Landing Width (in)	N/A	N/A	DWS Contrast?	N/A
N/A	Landing Slope (%)	N/A	N/A	DWS Length (in)	N/A
N/A	Landing X Slope (%)	N/A	N/A	DWS Full Width?	N/A
N/A	Landing Curb? (Y/N)	N/A	N/A	DWS Offset (in)	N/A
N/A	Shared Landing?	N/A			
N/A	Gutter Ponding?	N/A	N/A	Gutter Slope (%)	N/A
N/A	Gutter Lip Ht (in)	N/A	N/A	Gutter X Slope (%)	N/A
N/A	Painted X Walk1?	No	N/A	Painted X Walk2?	N/A
	X Walk 1 Direction	To W		X Walk 2 Direction	N/A
N/A	X Walk 1 Width (in)	N/A	N/A	X Walk 2 Width (in)	N/A
	X Walk 1 Slope (%)	5.3		X Walk 2 Slope (%)	N/A
	X Walk 1 X Slope (%)	1.1		X Walk 2 X Slope (%)	N/A

N/A	Ramp inside XWalk1?	N/A	N/A	Ramp inside XWalk2?	N/A
	Road Slope (%)	N/A	N/A	Clear Space?	N/A
	Road X Slope (%)	N/A	N/A	Clear Space to XWalk (in)	N/A
N/A	Any Obstructions?	N/A	N/A	Storm Grate/Utility Hazard?	N/A
	Obstruction Type		l	Storm Grate/Utility Type	
		N/A			N/A
			Yes	Surface Condition? (G/P)	Good

Possible Solutions:	<u>c</u>
Remove & Replace Entire Ramp.	N.
	N
	N.
	N.
	N
	N
Surveyor Notes:	N
N/A	N
	N
	N
	N
PROW/ADA:	N
R304.5.1, R304.2.2, R304.5.3	N.
	N
	N

Total Cost:	\$ 1850.00
