Access Compliance Report

Public Rights-of-Way

(Curb Ramps)

Intersection ID: 44955	Main Street: OAKTON_HUNT_DR	Cross Street: WEAVERS_GLENN_PL	Location: SE
ADA ID: 1A35901F081A	Ramp Type: PerpDiag	Initial Pass/Fail: Fail	Overall Compliance: No
Severity Score: 33.75			
Codes/Mitigation Info/Possible Solution		Field Measurements/Component Compliance

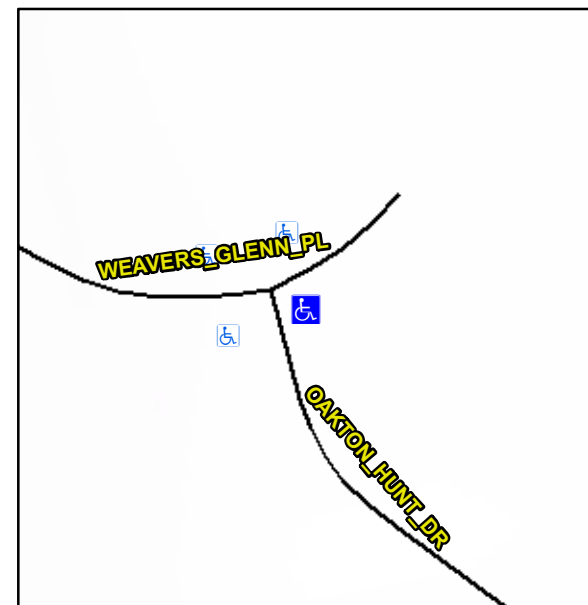
Not Found, R304.5.1, R304.5.3

Compliance	Description	Data	Compliance	Description	Data
N/A	Ramp Length (in)	46.0	Yes	Ramp Slope (%)	6.6
No	Ramp Width (in)	46.0	No	Ramp XSlope (%)	10.1
N/A	Flare Type LT	N/A	N/A	Flare Type RT	N/A
N/A	Flare Slope LT (%)	N/A	N/A	Flare Slope RT (%)	N/A
N/A	Flare Traversable LT?	N/A	N/A	Flare Traversable RT?	N/A
N/A	Landing Length (in)	N/A	N/A	DWS Provided?	N/A
N/A	Landing Width (in)	N/A	N/A	DWS Contrast?	N/A
N/A	Landing Slope (%)	N/A	N/A	DWS Length (in)	N/A
N/A	Landing X Slope (%)	N/A	N/A	DWS Full Width?	N/A
N/A	Landing Curb? (Y/N)	N/A	N/A	DWS Offset (in)	N/A
N/A	Shared Landing?	N/A			
N/A	Gutter Ponding?	N/A	N/A	Gutter Slope (%)	N/A
N/A	Gutter Lip Ht (in)	N/A	N/A	Gutter X Slope (%)	N/A
N/A	Painted X Walk1?	No	N/A	Painted X Walk2?	No
	X Walk 1 Direction	To N		X Walk 2 Direction	To W
N/A	X Walk 1 Width (in)	N/A	N/A	X Walk 2 Width (in)	N/A
	X Walk 1 Slope (%)	2.7		X Walk 2 Slope (%)	0.9
	X Walk 1 X Slope (%)	3.7		X Walk 2 X Slope (%)	7.4

N/A	Ramp inside XWalk1?	N/A	N/A	Ramp inside XWalk2?	N/A
	Road Slope (%)	6.8	N/A	Clear Space?	N/A
	Road X Slope (%)	4.7	N/A	Clear Space to XWalk (in)	N/A
N/A	Any Obstructions?	N/A	N/A	Storm Grate/Utility Hazard?	N/A
	Obstruction Type			Storm Grate/Utility Type	
		N/A			N/A
			Yes	Surface Condition? (G/P)	Good

Remove & Replace Curb Ramp With Two New Directional Ramps or Equivalent.
