Access Compliance Report Public Rights-of-Way (Curb Ramps)

Intersection ID: 19392 Main Street: CREEKRIDGE RD Cross Street: CREEKWOOD QUORUM DR Location: SE ADA ID: 1A36BF38BB51 Ramp Type: BlendTrans2 Initial Pass/Fail: Fail **Overall Compliance: No Severity Score:** 25

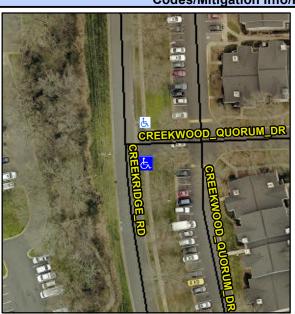
Compliance Description		Data	Compliance Description		Data
N/A	Ramp Length (in)	33.0	Yes	BlendTrans Slope (%)	0.6
Yes	Ramp Width (in)	48.0	No	BlendTrans XSlope (%)	10.1
N/A	Flare Type LT	N/A	N/A	Flare Type RT	N/A
N/A	Flare Slope LT (%)	N/A	N/A	Flare Slope RT (%)	N/A
N/A	Flare Traversable LT?	N/A	N/A	Flare Traversable RT?	N/A
N/A	Landing Length (in)	N/A	N/A	DWS Provided?	N/A
N/A	Landing Width (in)	N/A	N/A	DWS Contrast?	N/A
N/A	Landing Slope (%)	N/A	N/A	DWS Length (in)	N/A
N/A	Landing X Slope (%)	N/A	N/A	DWS Full Width?	N/A
N/A	Landing Curb? (Y/N)	N/A	N/A	DWS Offset (in)	N/A
N/A	Shared Landing?	N/A			
N/A	Gutter Ponding?	N/A	N/A	Gutter Slope (%)	N/A
N/A	Gutter Lip Ht (in)	N/A	N/A	Gutter X Slope (%)	N/A
N/A	Painted X Walk1?	No	N/A	Painted X Walk2?	No
	X Walk 1 Direction	To N		X Walk 2 Direction	To W
	X Walk 1 Width (in)	N/A		X Walk 2 Width (in)	N/A
	X Walk 1 Slope (%)	1.2		X Walk 2 Slope (%)	9.8
	X Walk 1 X Slope (%)	12.0		X Walk 2 X Slope (%)	2.2

N/A	Ramp inside XWalk1?	N/A	N/A	Ramp inside XWalk2?	N/A
	Road Slope (%)	7.6		Clear Space?	N/A
	Road X Slope (%)	1.5	N/A	Clear Space to XWalk (in)	N/A
N/A	Any Obstructions?	N/A	N/A	Storm Grate/Utility Hazard?	N/A
	Obstruction Type			Storm Grate/Utility Type	
		N/A	l		N/A
			Yes	Surface Condition? (G/P)	Good
4000			No	Curb Slope (%)	12.1

Possible Solutions: Remove & Replace Curb Ramp With Two New Directional Ramps or Equivalent. Surveyor Notes: **NO LNDG** PROW/ADA: Not Found, R304.5.3
