# Access Compliance Report

## Public Rights-of-Way

| Intersection ID: 2555 | Main Street: PELORUS_LN | Cross Street: TARBY_CT | Location: S |
| ADA ID: 1A37C8E38610 | Ramp Type: PerpDiag | Initial Pass/Fail: Pass | Overall Compliance: No |

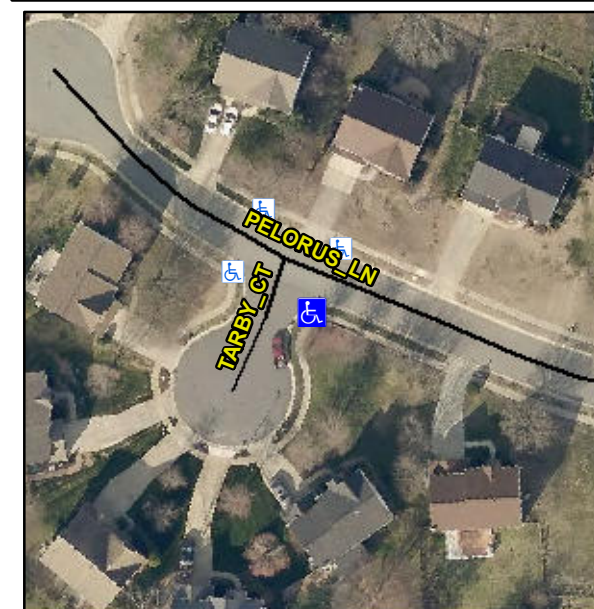
Surveyor Notes:

**N/A**

**R304.2.1, R304.2.2-Perp, R304.3.2-Para, R305.2, R304.5.3**

| Compliance | Description | Data | Compliance | Description | Data |
|---|---|---|---|---|---|
| No | Landing Length (in) | 48.0 | Yes | DWS Provided? | Yes |
| No | Landing Slope (%) | 4.0 | Yes | DWS Length (in) | 25.5 |
| N/A | Landing Curb? (Y/N) | Yes | No | DWS Offset (in) | 7.0 |
| Yes | Gutter Lip Ht (in) | 0.0 | No | Gutter X Slope (%) | 2.5 |

Possible Solutions:

**Remove & Replace Curb Ramp With Two New Directional Ramps or Equivalent. Remove & Replace Gutter.**

Total Cost: \$ 3950.00
